Qualitative Infrared Report  
Residential Condominium  
Roof System: Foam Roof on Concrete Deck

Visible and Infrared Images were taken 5/16/19 of Building 6.  
Analysis of IR images will be further detailed on the following pages specific to each building.

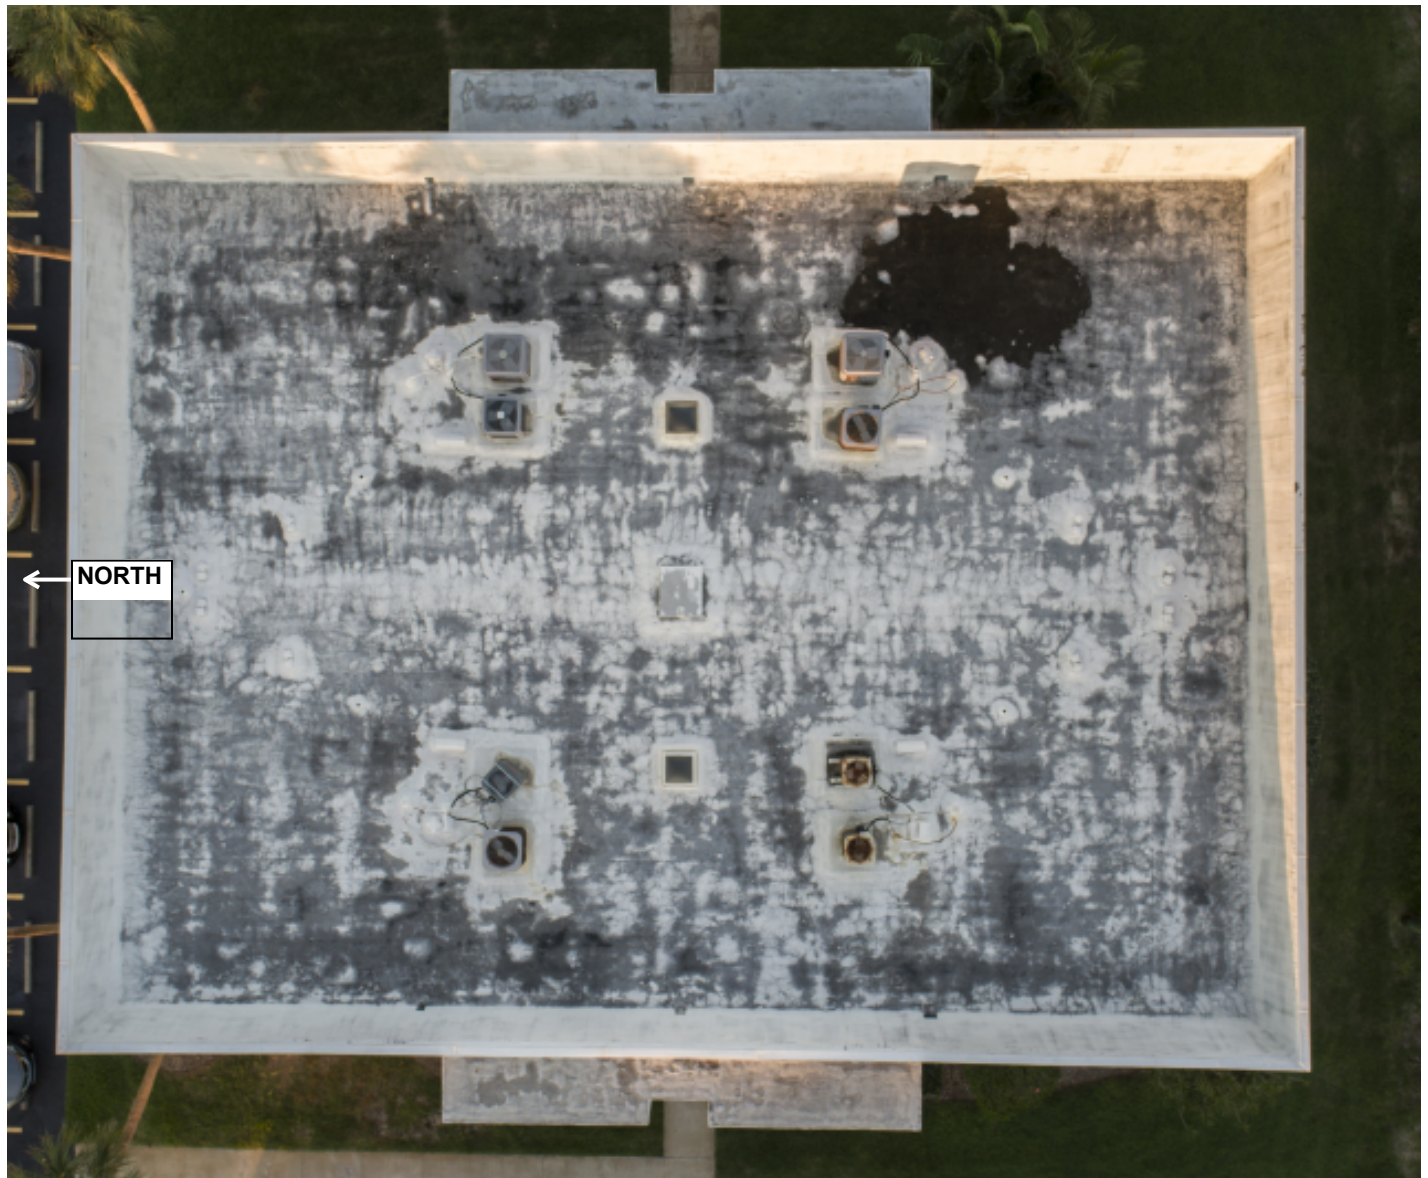
Building\_6\_Top\_Down\_1.jpg

Pictured here is a visible top down image of Building 6. This roof construction is foam on concrete.

Noticeable stains can be seen along with a visible dark area in the South East corner. This dark area appears to be asphalt or similar material and possibly a previous patch and/or repair. This area did not show a rise in temperature or thermal anomaly.

Areas of concern that should be physically investigated will be marked on pages 4 and 5 and includes an IR image of this roof and another visible image with a red zebra pattern marking indicating areas where temperature anomalies were observed and should be physically examined.

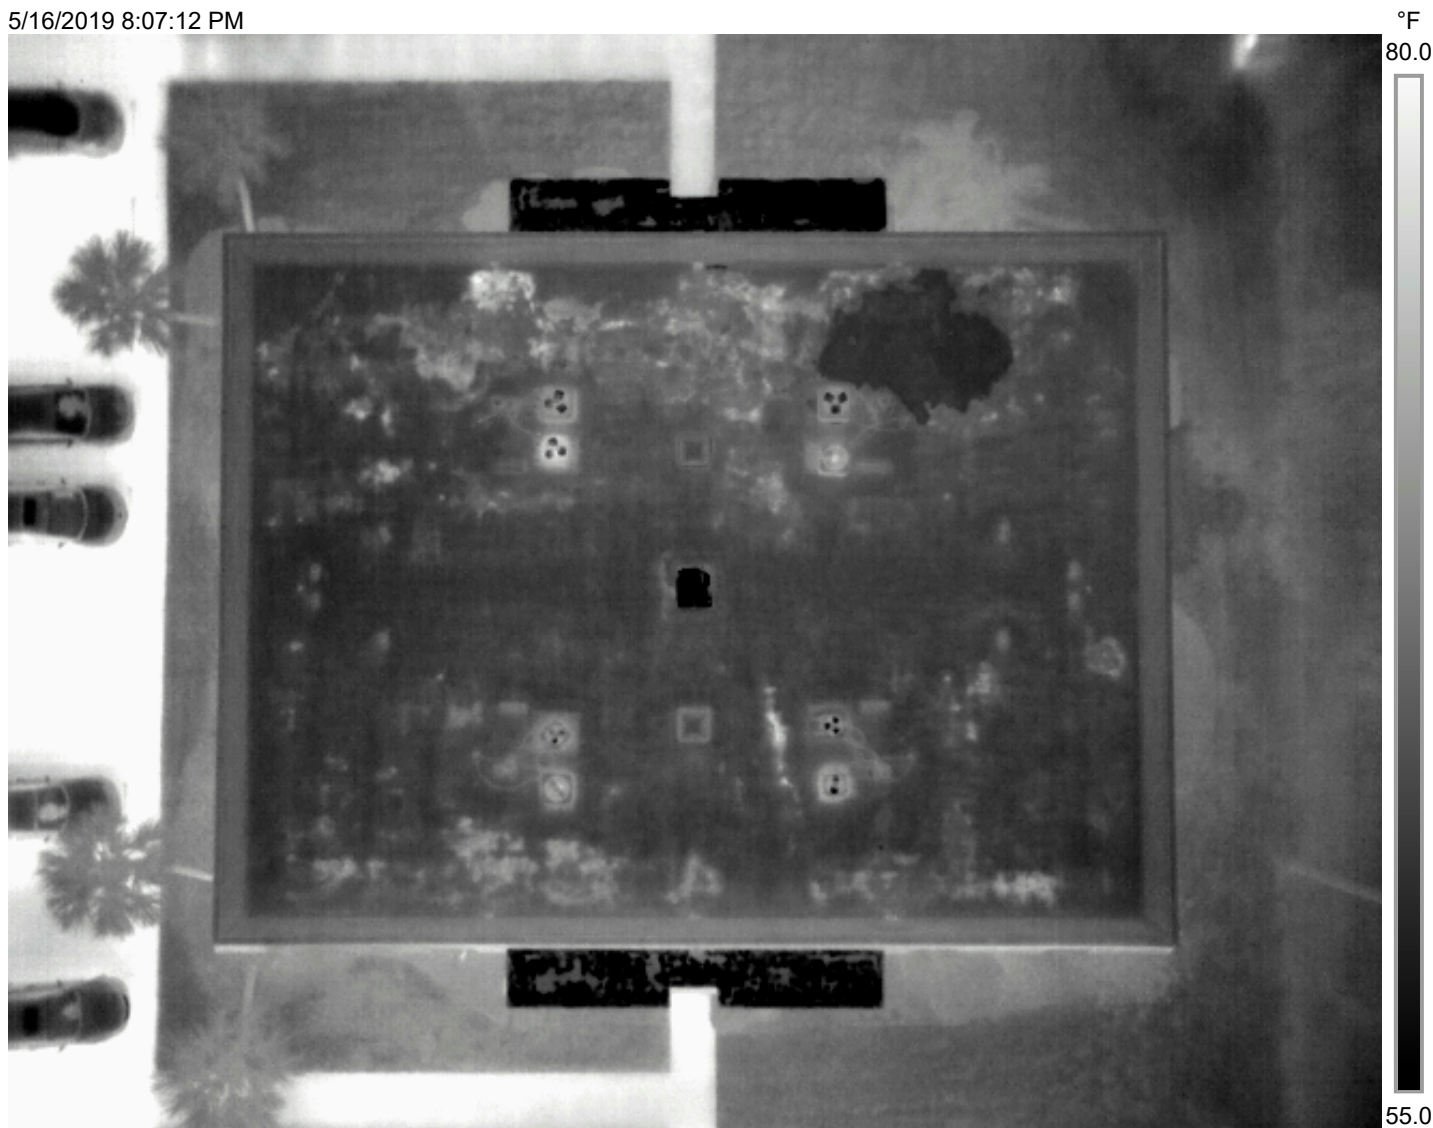
DJI\_0184\_R.JPG

Pictured here is an Infrared top down image of Building 6. This roof construction is foam on concrete.

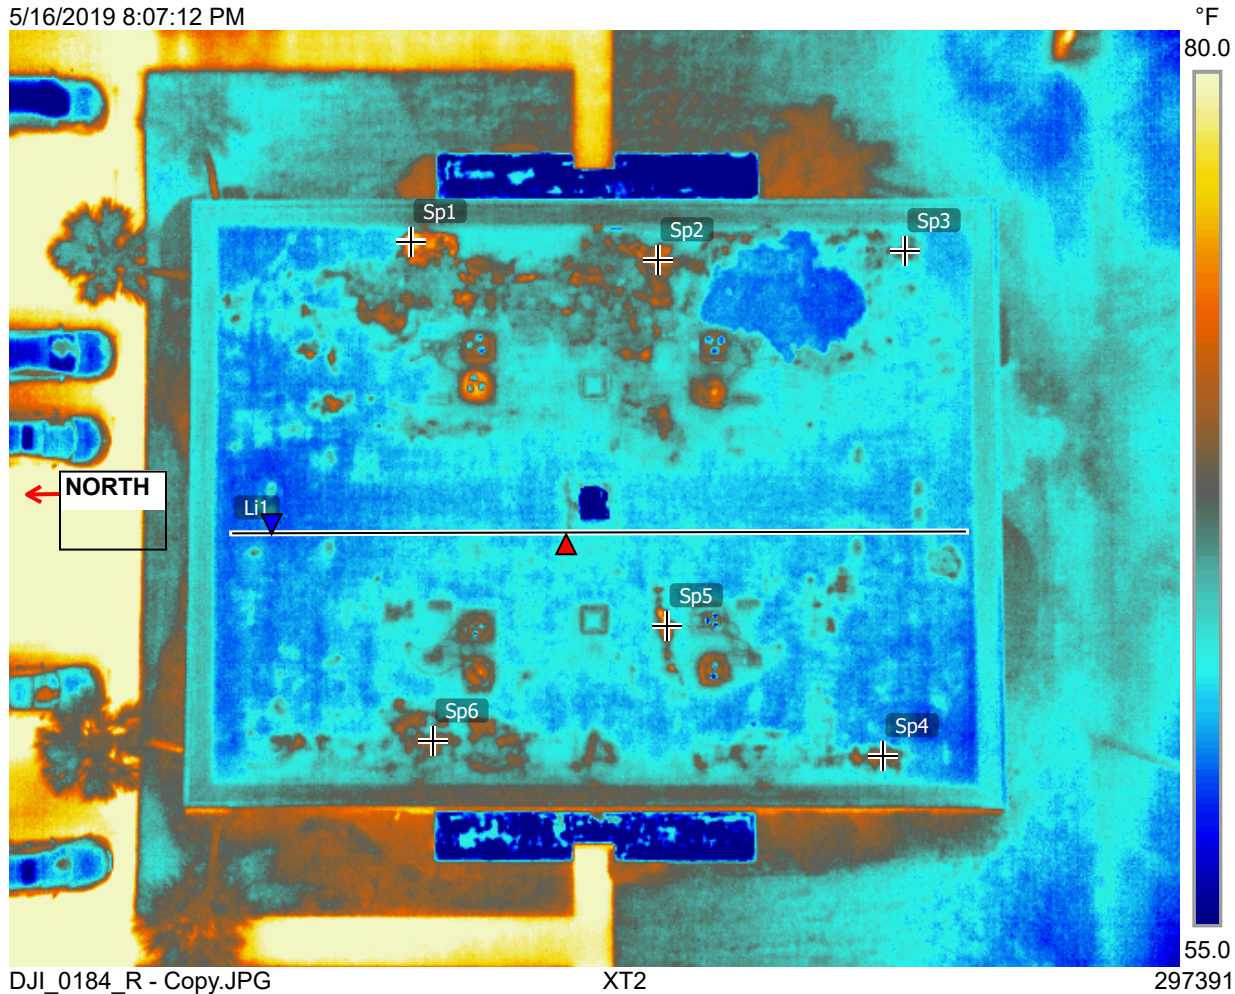
Pictured here is an Infrared top down image of Building 6. This roof construction is foam on concrete. In this IR image the palette displayed is Arctic.

A temperature measurement line placed across the roof from North to South shows an average temperature of 61.7 degrees on the roof surface.

Spot meter checks on several areas showing anomalies indicated a rise in temperature of more than 10 degrees.

These areas with increased temperature readings will be marked on the following page with a red striped zebra pattern and would need to be physically investigated to verify the presence of any moisture penetration.

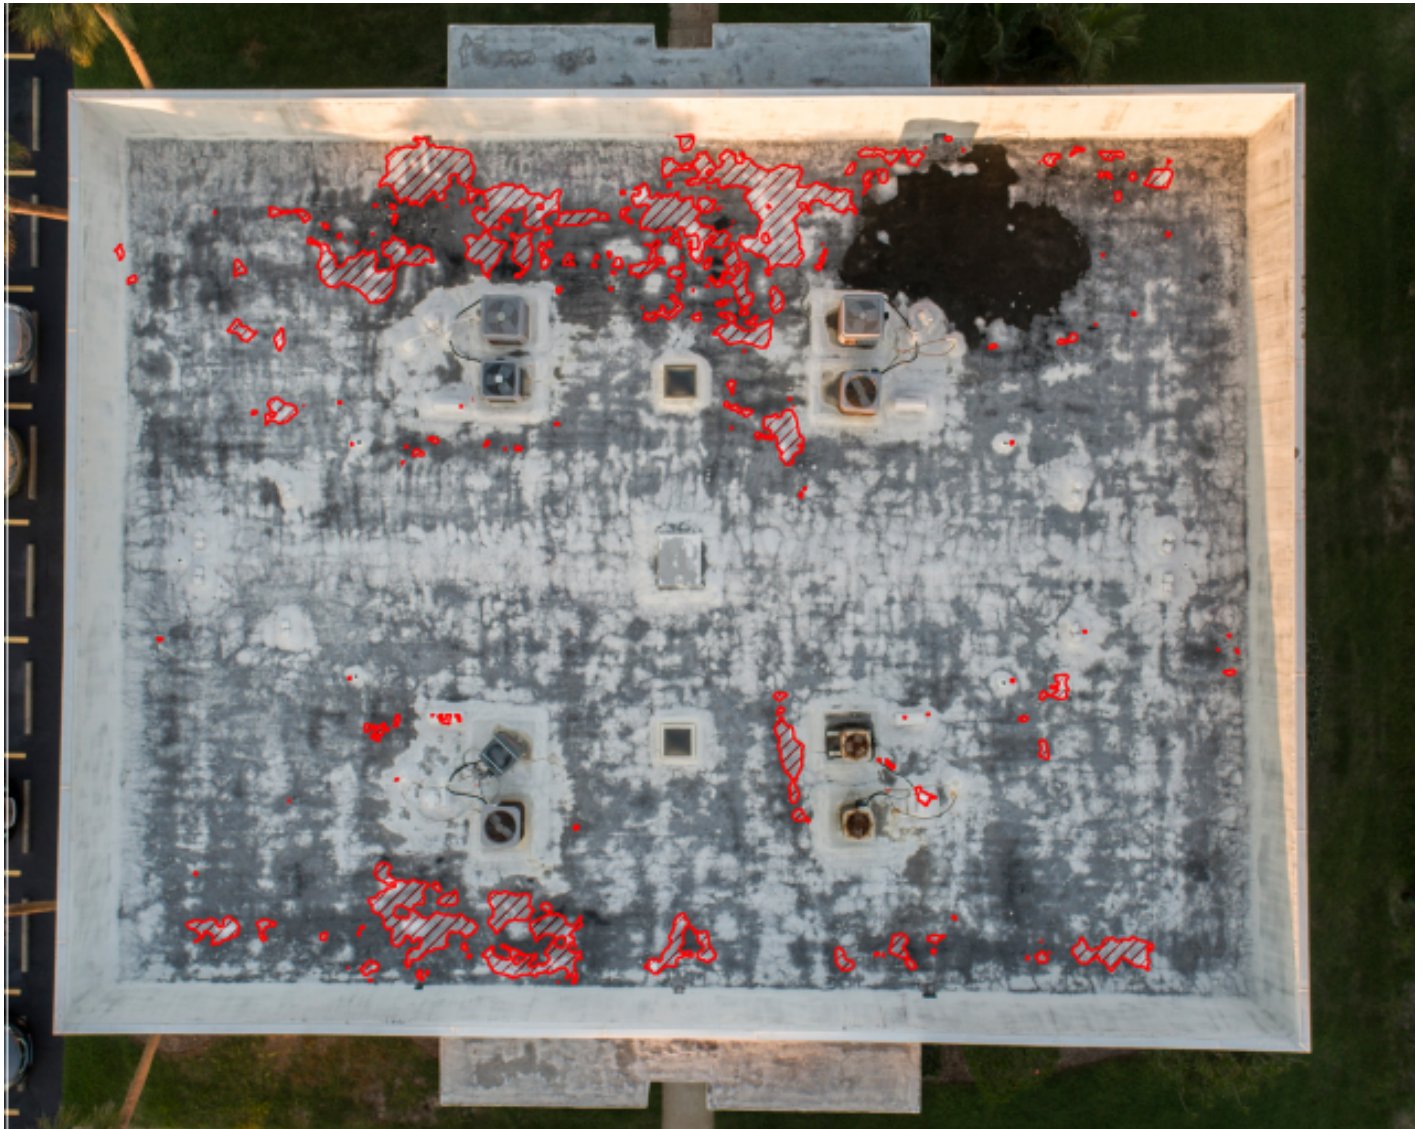
Building\_6\_Zebra\_Visible.jpg

These areas with increased temperature readings are marked above with a red striped zebra pattern. These areas would need to be physically investigated to verify the presence any moisture penetration.

**MOISTURE VERIFICATION:** Infrared Thermography is a powerful tool for nondestructive Testing and Analysis of flat roofing systems. However, to insure complete accuracy of the survey results, it is necessary to physically verify the presence of moisture within the roofing system. All indicated anomalies marked with a red zebra pattern on the report images should be physically examined.

**PHYSICAL TESTING:** A core sample if taken should begin at any locations of concern marked with arrows or a red zebra pattern to verify moisture presence and water penetration. Physical testing and analysis can also be accomplished through the use of a moisture meter with electrically charged pin probes.
