Cocoa, FL USA

Roof System: SPF Roof w/ Gaco Silicone Coating.

Visible and Infrared Images were taken 4/19/18 of Whitney Bay Condominiums. Analysis of IR images will be further detailed on the following pages.

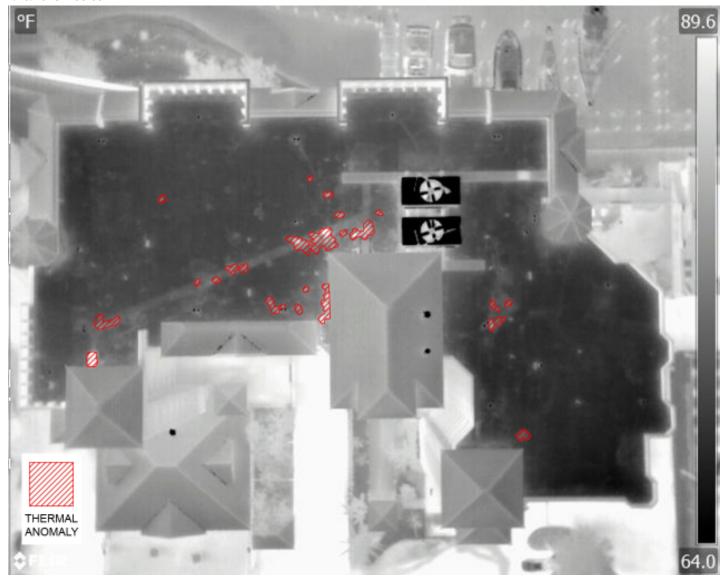
Overall_IR.jpg
Geolocation

Pictured above is a top down view infrared image in the "white is hot" palette. Areas that indicate temperature anomalies are marked with a red striped pattern. In many instances the marked areas showed temperature differences greater than 15 degrees. Several of these spot measurements will be shown in more detail on page 4.

Due to the high heat capacity of water over most surface materials along with the physical verification (performed by condo president) that the roof was dry at time of IR scan, the areas marked with red should be physically inspected by a facility manager or licensed roofing contractor.

This increase in temperature displayed above is often an indication of water penetration or water saturation and will require a physical inspection to verify.

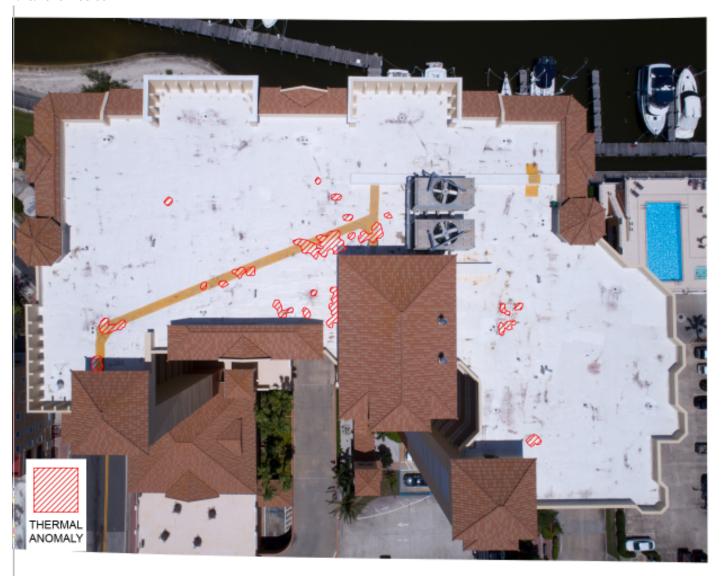
Overall_Visible.jpg

Pictured above is a visible RGB aerial photo of Whitney Bay Condominium taken in a top down view for IR and report reference. A silicone based coating was applied over sprayed foam. Areas of questionable anomalies that should be physically investigated are marked above with a red striped pattern. In many instances the marked areas showed temperature differences greater than 15 degrees. These measurments are shown on the following page.

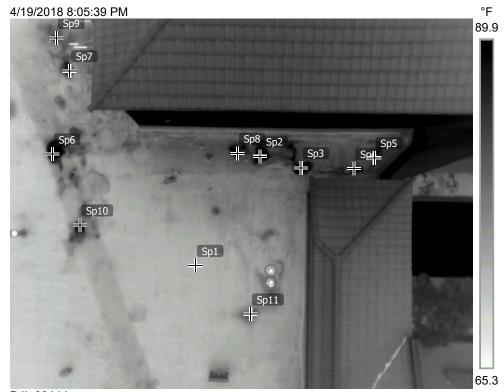
DJI_0044.jpg 4/19/2018 8:05:39 PM

Measurements	
Sp1	72.5 °F
Sp2	87.8 °F
Sp3	89.4 °F
Sp4	90.5 °F
Sp5	88.0 °F
Sp6	93.9 °F
Sp7	89.0 °F
Sp8	88.5 °F
Sp9	84.7 °F
Sp10	88.1 °F
Sp11	81.9 °F
Parameters	
Emissivity	0.85
Refl. temp.	71.6 °F

Spot 1 noted in the thermal image above was used as a reference point for baseline temperature. Note that spot 6 is 20 degrees warmer than the reference point. This occurs over the walkway.

All areas marked with red should be physically inspected by a facility manager or licensed roofing contractor.

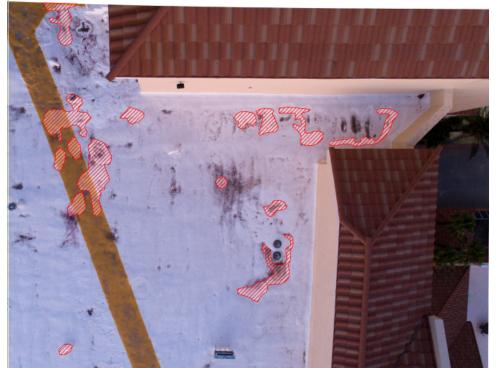
Close_Up_Visible.jpg

Pictured above on this page is a "Black is Hot" Infrared image along with a Visible RGB image for reference to the left.
