Thermal Imaging Date: Thursday March 1st 2018 Time of Thermal Imaging: Approx. 7:15 P.M CST. Sky Conditions: Clear at scan - Daytime Partly Cloudy. Daytime Temperature High: 73 Degrees Fahrenheit Temperature at time of Infrared Imaging: 61 Degrees Fahrenheit Wind Speed: 13mph NNE Humidity:67%

Imaging Performed by: Todd A. Hillhouse (Level III Thermographer) Roofing Surface: Modified Bitumen Surface Condition: Dry at surface. Roof had been swept and dried prior to scan. Infrared Camera Type: Zenmuse XT-R Powered by FLIR 30hz 640x512 13mm Imaging Altitude: 100 ft AGL - 300 ft AGL

QUALITATIVE INFRARED REPORT Building: Corporate Data Center w/ Low Slope Roof Roof Surface: Modified Bitumen City/State: San Antonio, TX

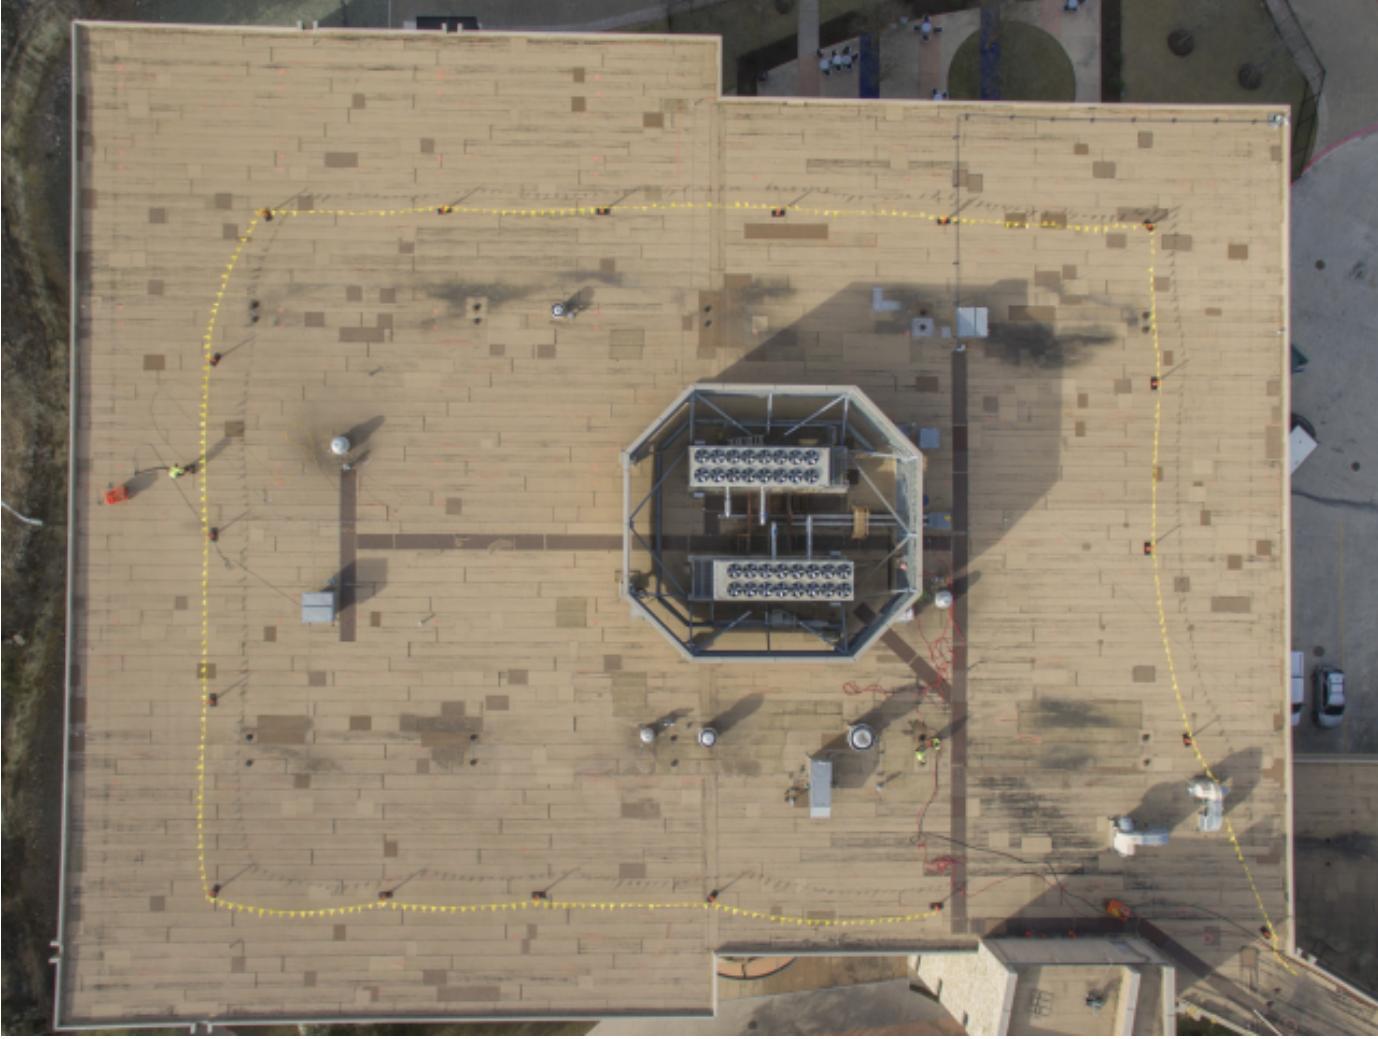
Building_A_TD.jpg

Pictured here is Building A. Some noticable stains along with loose granules can be seen. Areas of concern that should be investigated will be marked on the following pages that include IR images of this roof.

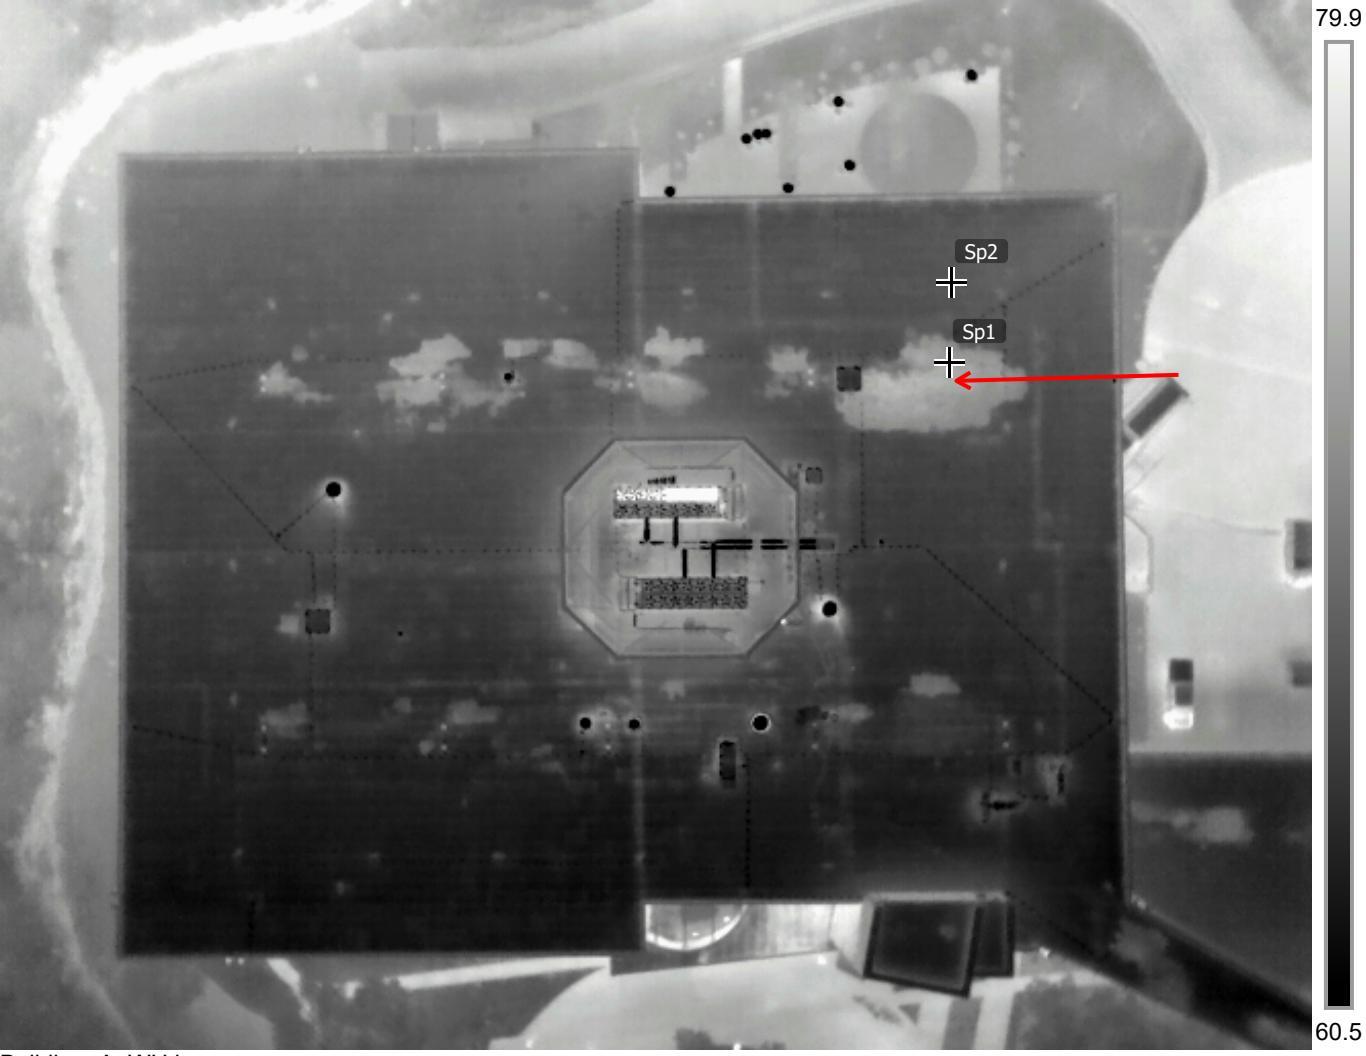
Building_A_WH.jpg

Sp1	73.7 °F
Sp2	67.8 °F
Parameters	
Emissivity	0.9
Refl. temp.	71.6 °F
Note	
Building_A

Recommend doing a core at the location of red arrow. Spot 1 is several degrees higher than spot 2. The white areas indicate a higher temperature than the darker areas. The white areas extend out past the visible image stains, indicating not just a difference in material but a temperature anomaly that needs to be investigated. These areas will be marked with red zebra pattern on the following page.

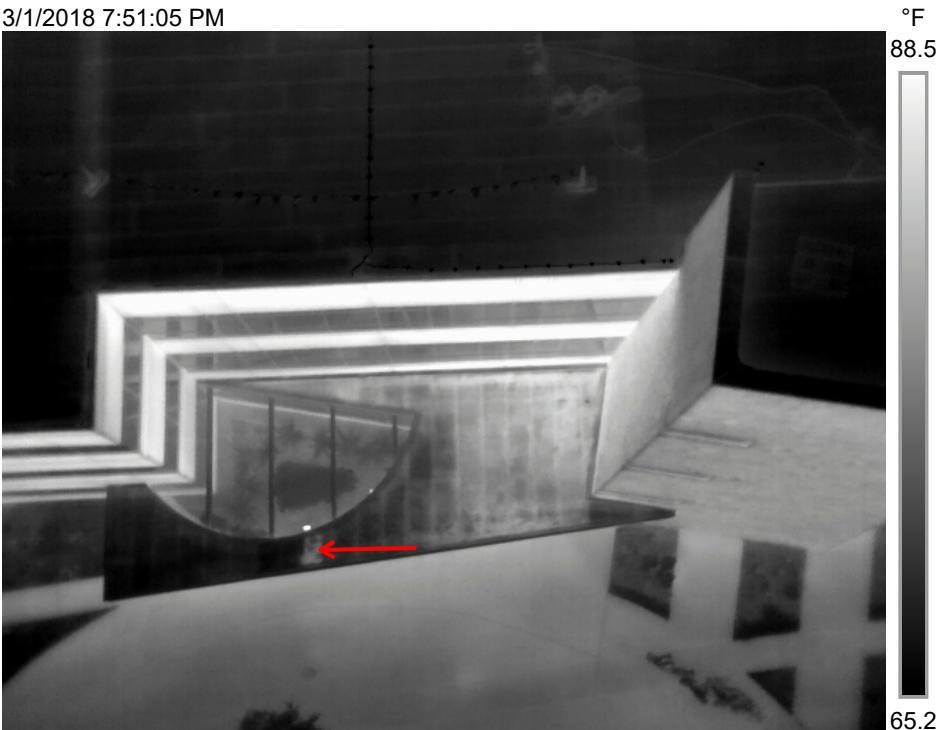
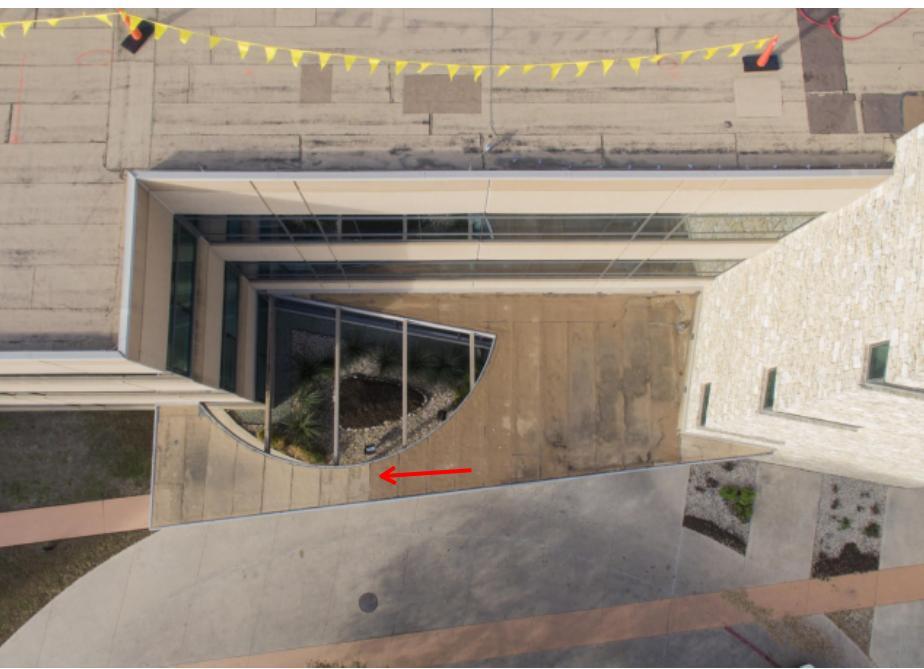
Note **Building A Lower Roof**

Pictured here is the lower roof connected to Building A. This roof due to its small size and condition should be physically examined in its entirety. The clearest anomaly here is marked with a red arrow and should be physically examined for moisture. In other areas the increase in temperature could be contributed to heat transfer from the building, although the visible image displays surface stains and possible indication of surface dampness from rain or pressure cleaning or a possible previoius repair. (Due to difference in material color.)

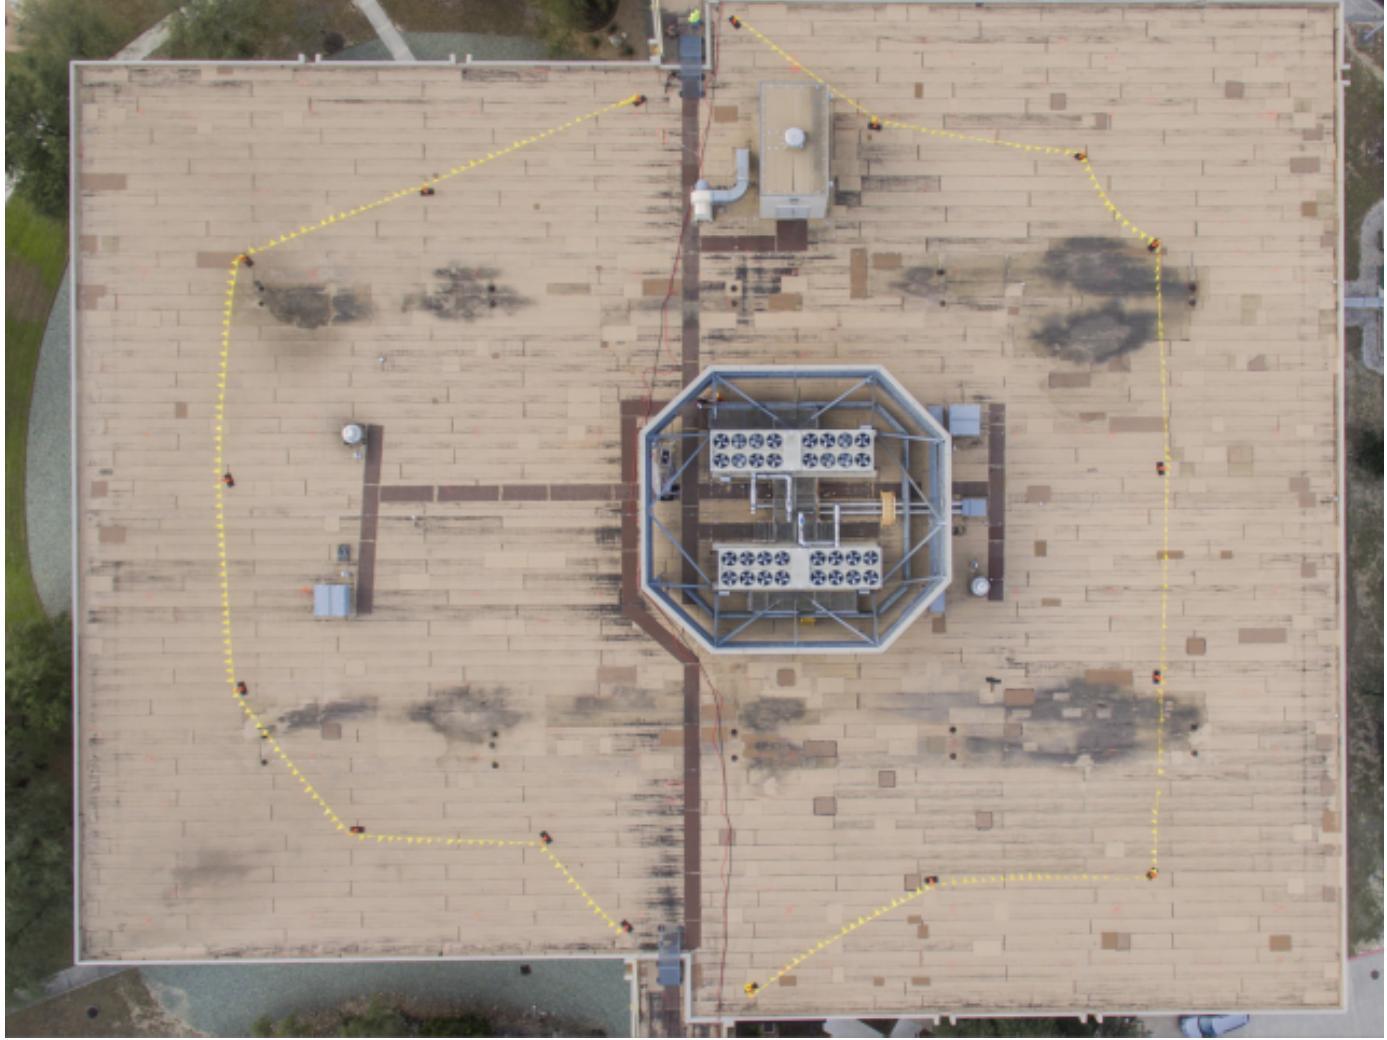
Building_B_TD.jpg

Pictured here is Building B. Many noticable dark stains along with loose granules can be seen. Areas of concern that should be investigated will be marked on the following pages that include IR images of this roof. The Infrared images will show anomalies that extend out far past the stains.

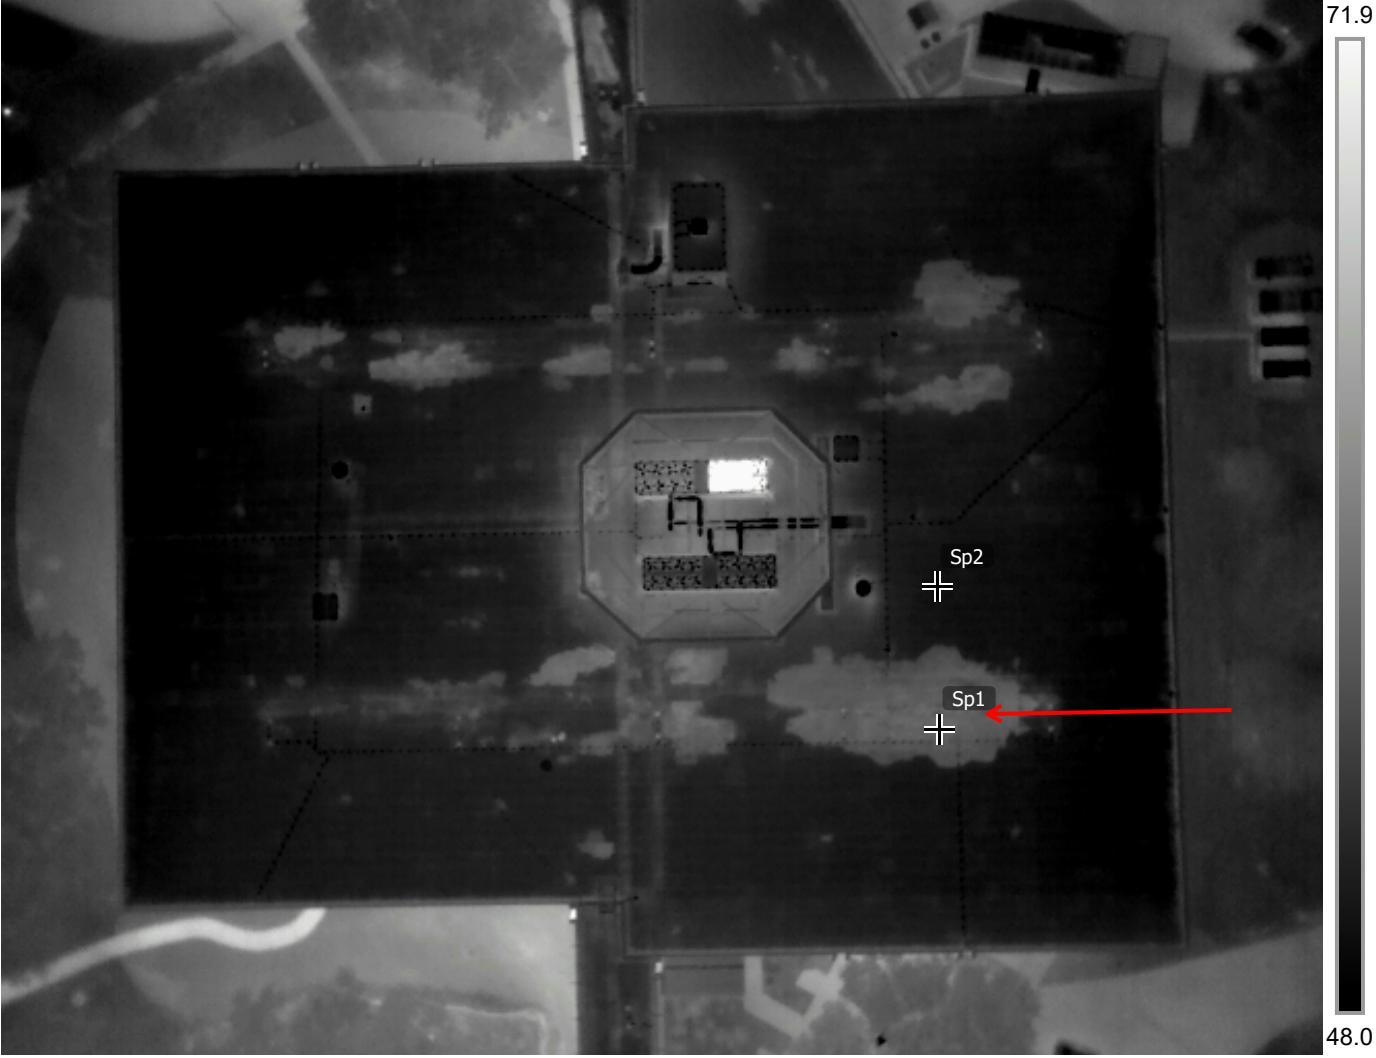
Building_B_WH.jpg

Measurements	
Sp1	58.3 °F
Sp2	50.5 °F
Parameters	
Emissivity	0.9
Refl. temp.	71.6 °F
Note	
Building B

Recommend doing a core at the location of red arrow. Spot 1 is several degrees higher than spot 2. The white areas indicate a higher temperature than the darker areas. The white areas extend out past the visible image stains, indicating not just a difference in material but a temperature anomaly that needs to be investigated. These areas of concern will be marked with red zebra pattern on the following page.

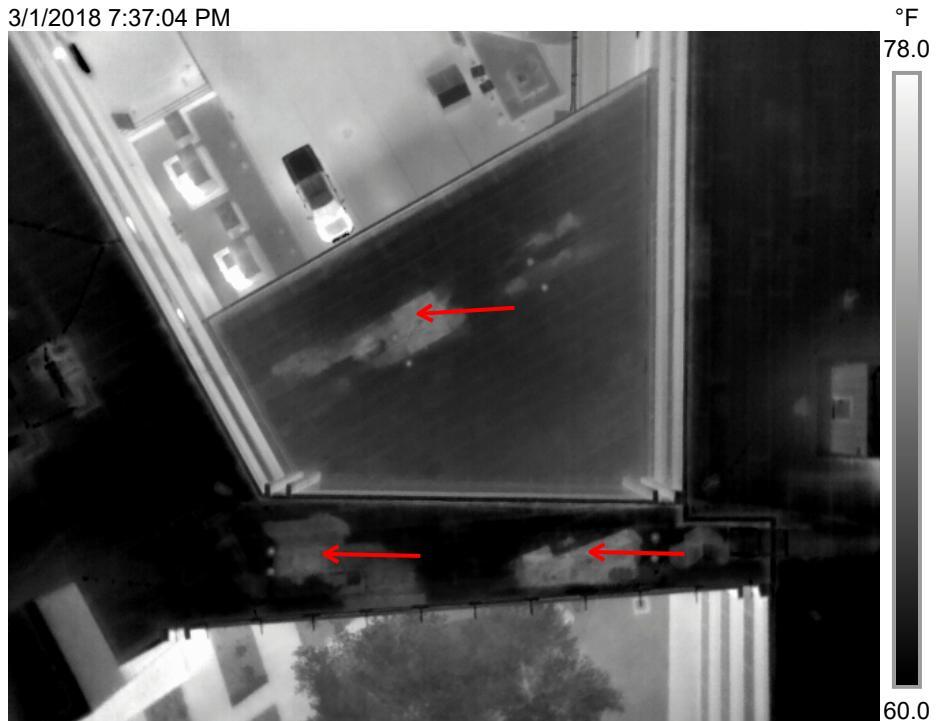
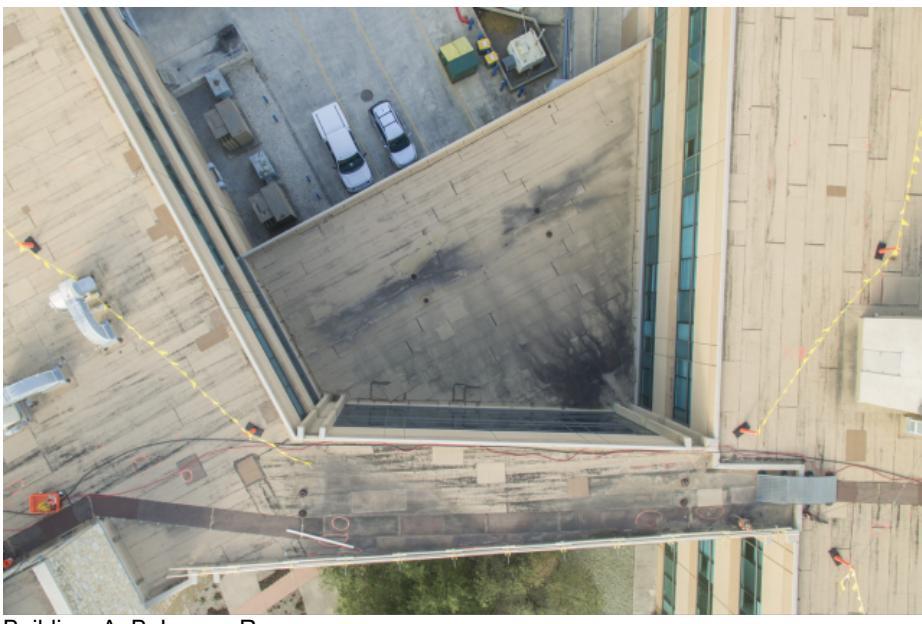
Building_A_B_Lower_WH.jpg

Pictured here is the lower roof and walkway between Buildings A and B. Many noticable dark stains can be seen. Areas of concern that should be investigated will be marked on the following pages. Recommend doing a core at the location of red arrows. Areas of concern are marked on the following page with red zebra pattern.

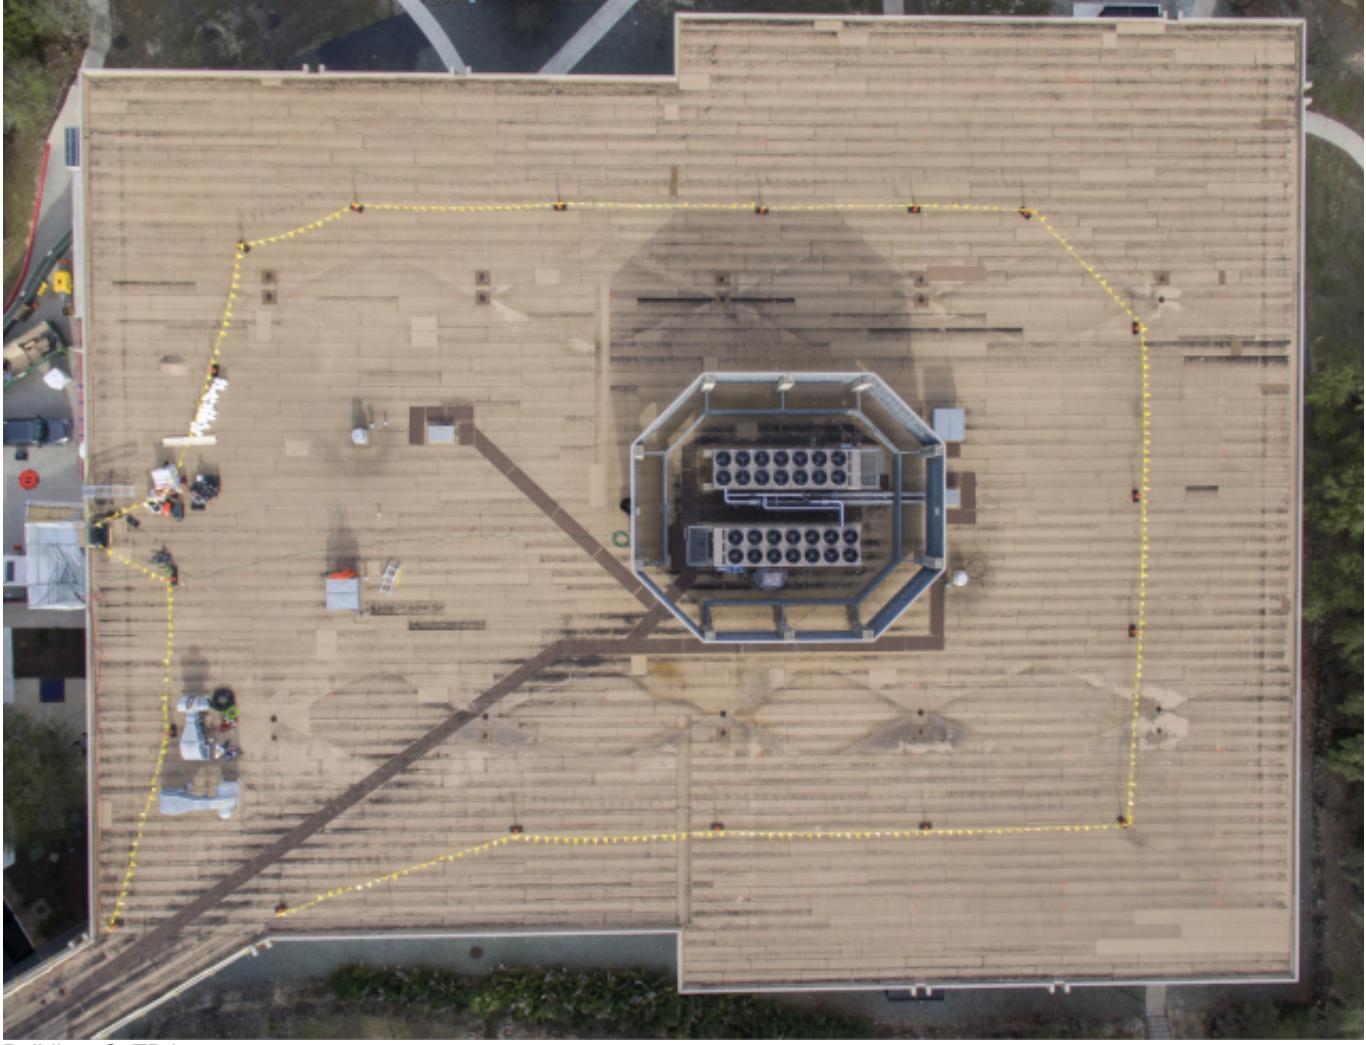
Building_C_TD.jpg

Pictured here is Building C. A few noticable surface stains along with loose granules can be seen. There was some material and equipment staged on this roof that will show up in IR images. Areas of concern that should be investigated will be marked on the following pages that include IR images of this roof. Overall this building showed very few anomalies appearing in the Infrared Imaging.

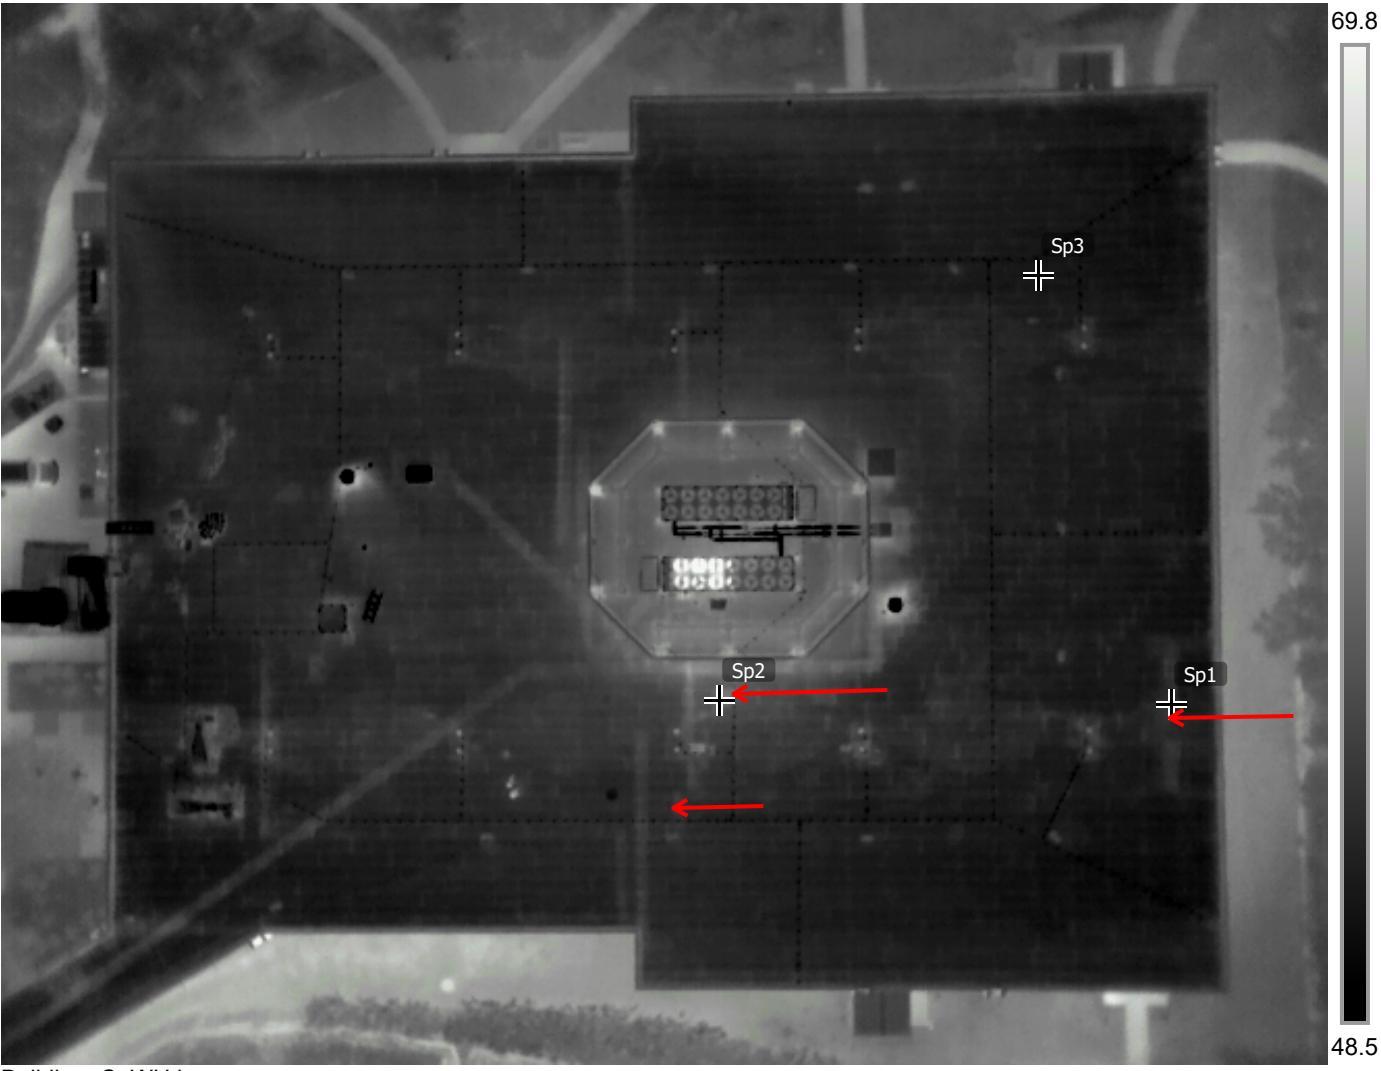
Building_C_WH.jpg

Sp1	54.5 °F
Sp2	59.2 °F
Sp3	51.0 °F
Parameters	
Emissivity	0.9
Refl. temp.	69 °F
Note	
Building_C

The white areas indicate difference in material or a higher temperature than the darker areas. The areas of concern will be marked with red zebra pattern on the following page.

Overall very few anomalies that would indicate moisture penetration were found on this roof.

Recommend doing a core at the location of red arrows.

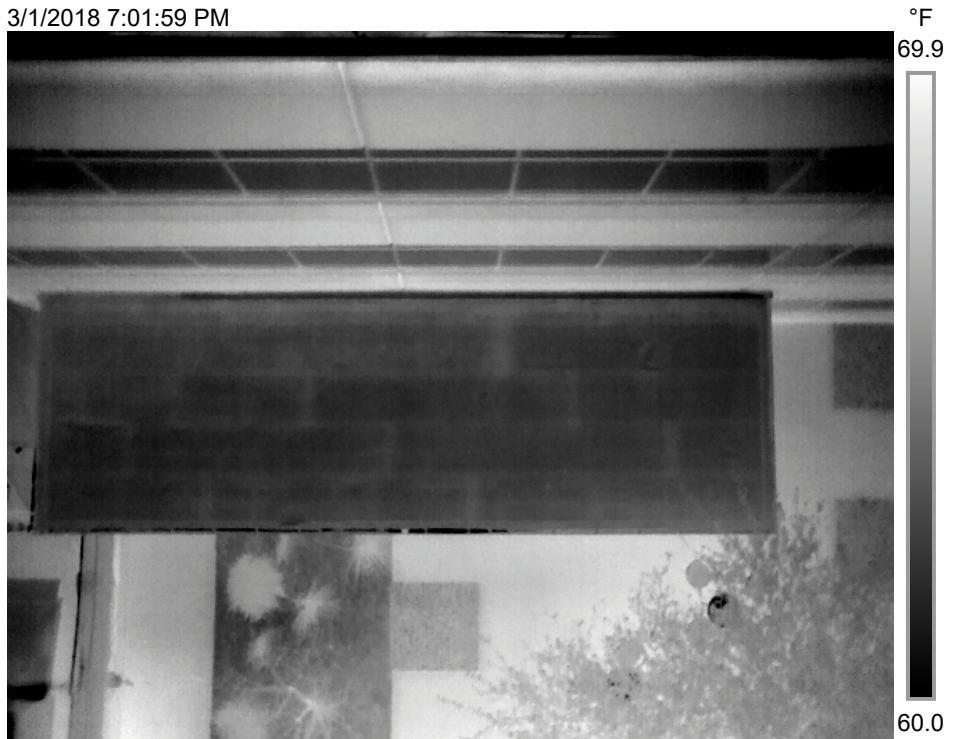
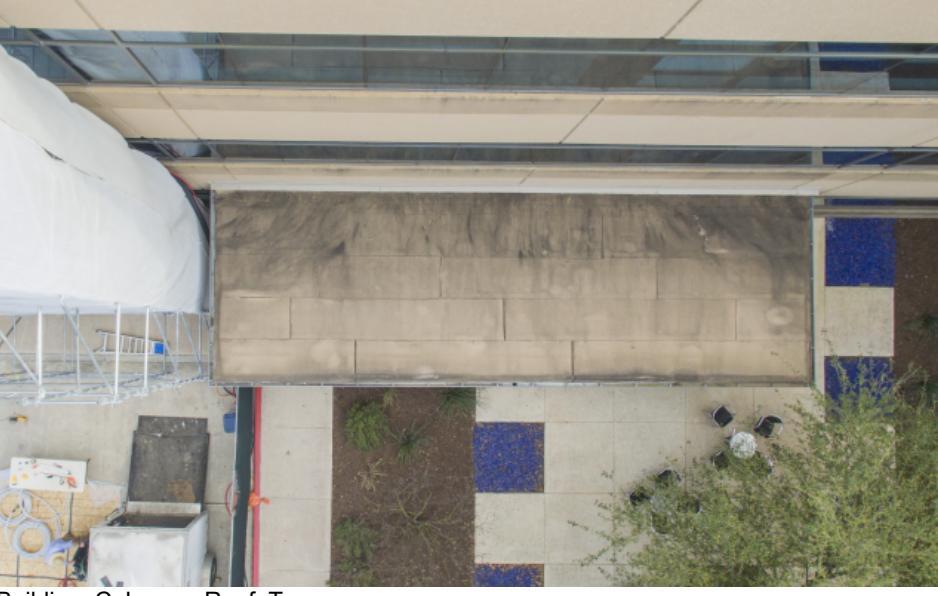
Building_C_WH_Lower.jpg

Pictured here is the lower roof connected to Building C. Surface stains can be seen on the visible image. No areas of concern were found with the infrared imaging of this lower roof.
