Thermal Imaging Date: Friday September, 28th 2018 Time of Thermal Imaging: Approx. 7:20 P.M EST. Sky Conditions: Fair - Daytime: Fair Daytime Temperature High: 92 Degrees Fahrenheit Temperature at time of Infrared Imaging: 86 Degrees Fahrenheit Wind Speed: 9 mph ESE Humidity: 67%

Visible and Infrared Images were taken on 9/28/2018 of Buildings 1,2,3,4,5,6,7,8,9,10,11,12,13,14,15,16,17,18 & 26. Analysis of IR images will be further detailed on the following pages specific to each building.

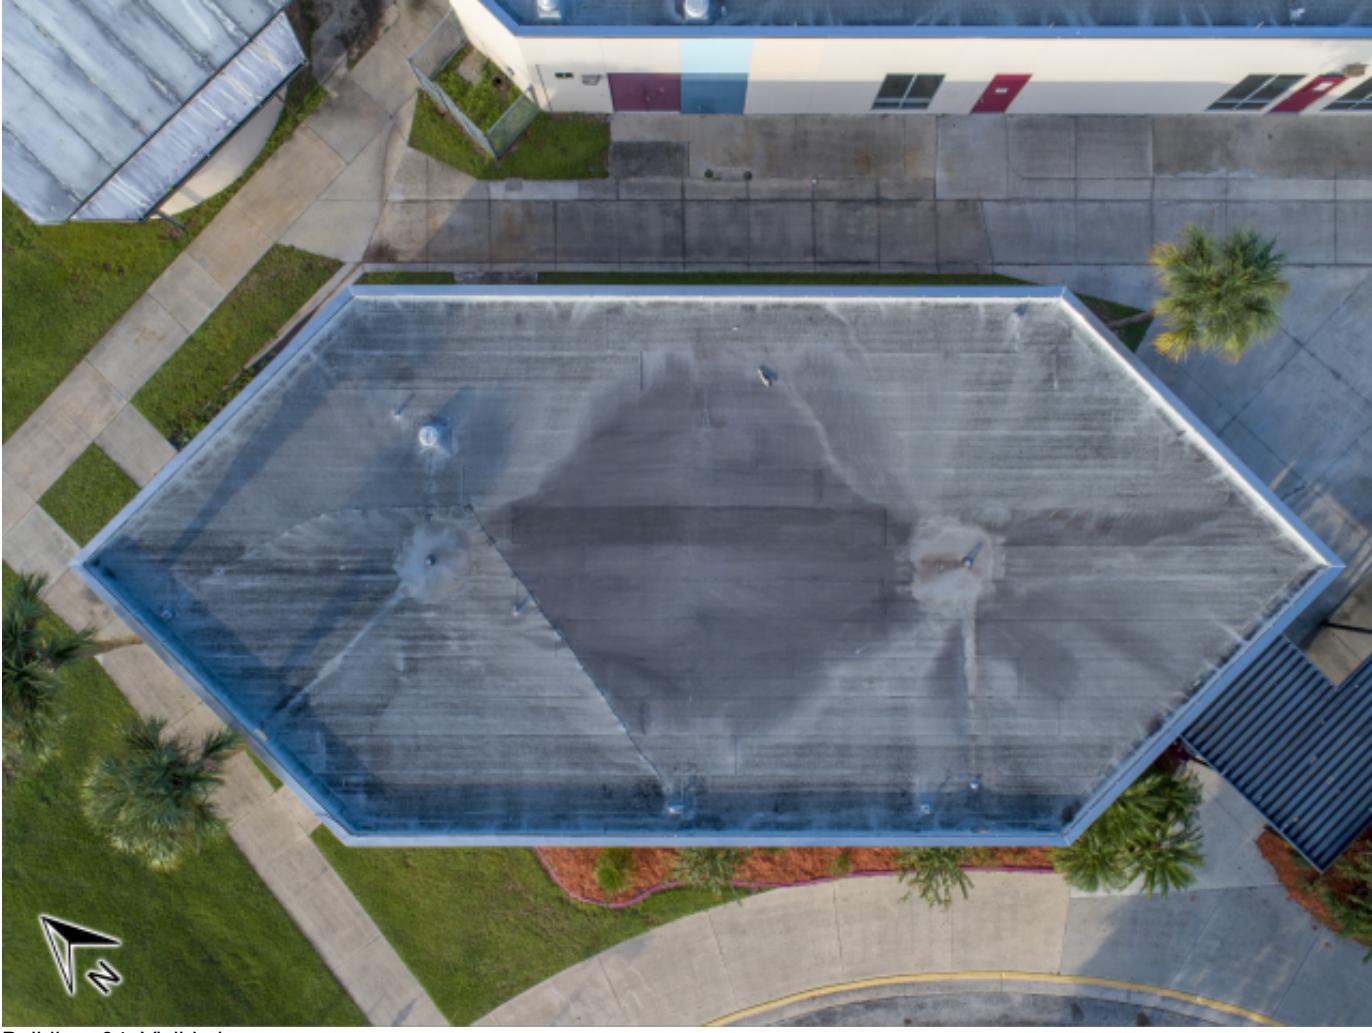
Pictured here is Building 04. This roof is modified bitumen. Noticeable stains, granular buildup and drainage flow patterns can be seen. Areas of concern that should be investigated will be marked on the following pages that include IR images of this roof.

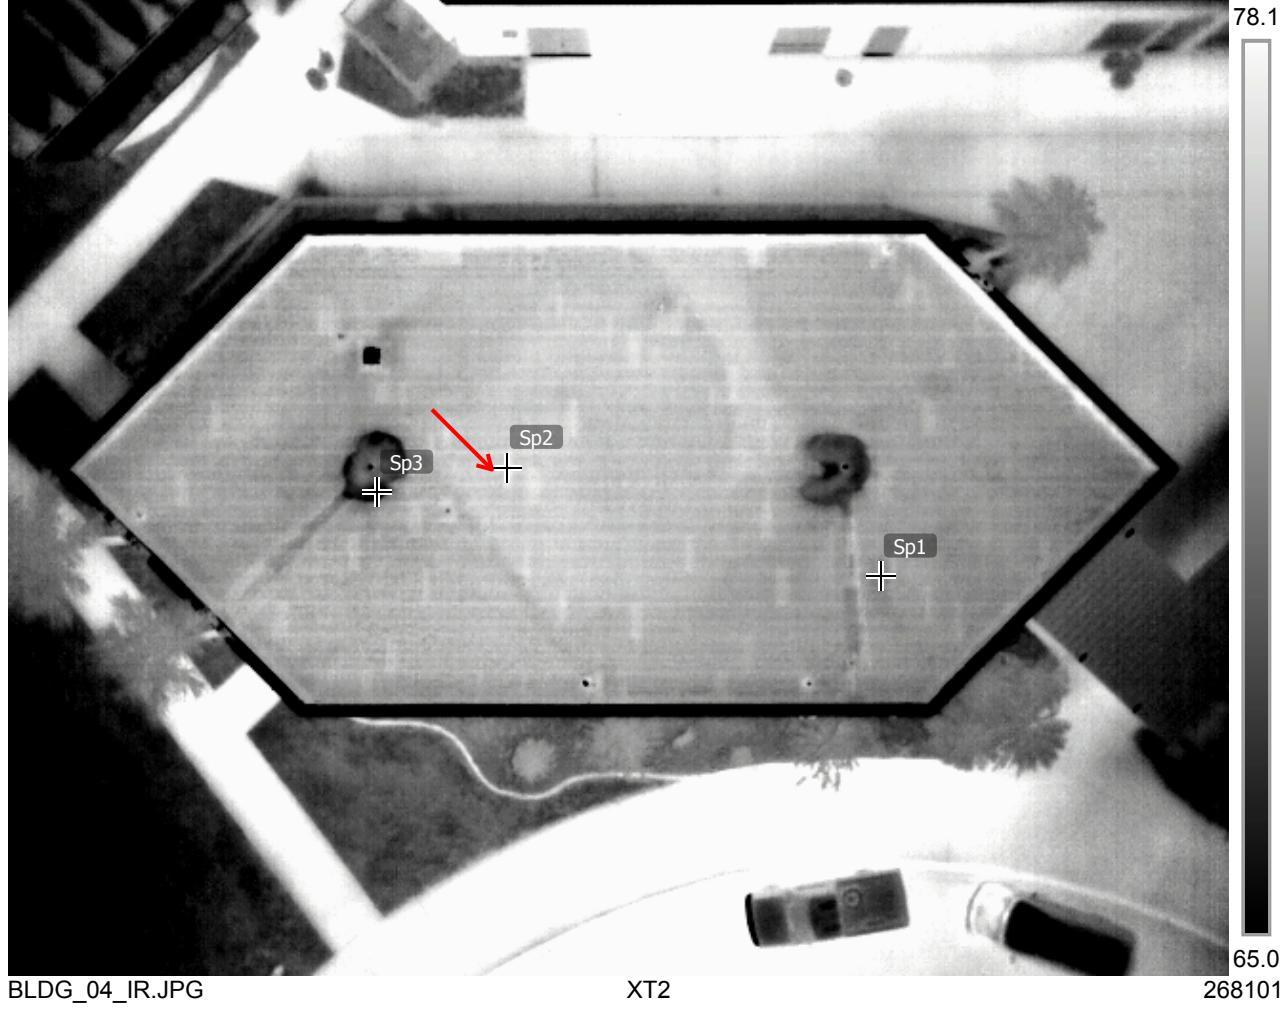
Building 04

mododromon	0	
Sp1		71.8 °F
Sp2		77.6 °F
Sp3		63.4 °F
Dt1	Sp1 - Sp2	-5.8 °F

The whiter areas indicate a higher temperature than the darker areas. The darker, cooler, areas including Sp3 are caused by granular build up. On the following page these areas are marked by an orange zebra pattern.

There are thermal anomalies in the granular build up area on both drains which is warmer towards the drain. Recommend doing a core sample at the location of red arrow on this page and further physically investigate areas with the red zebra pattern on the following page.

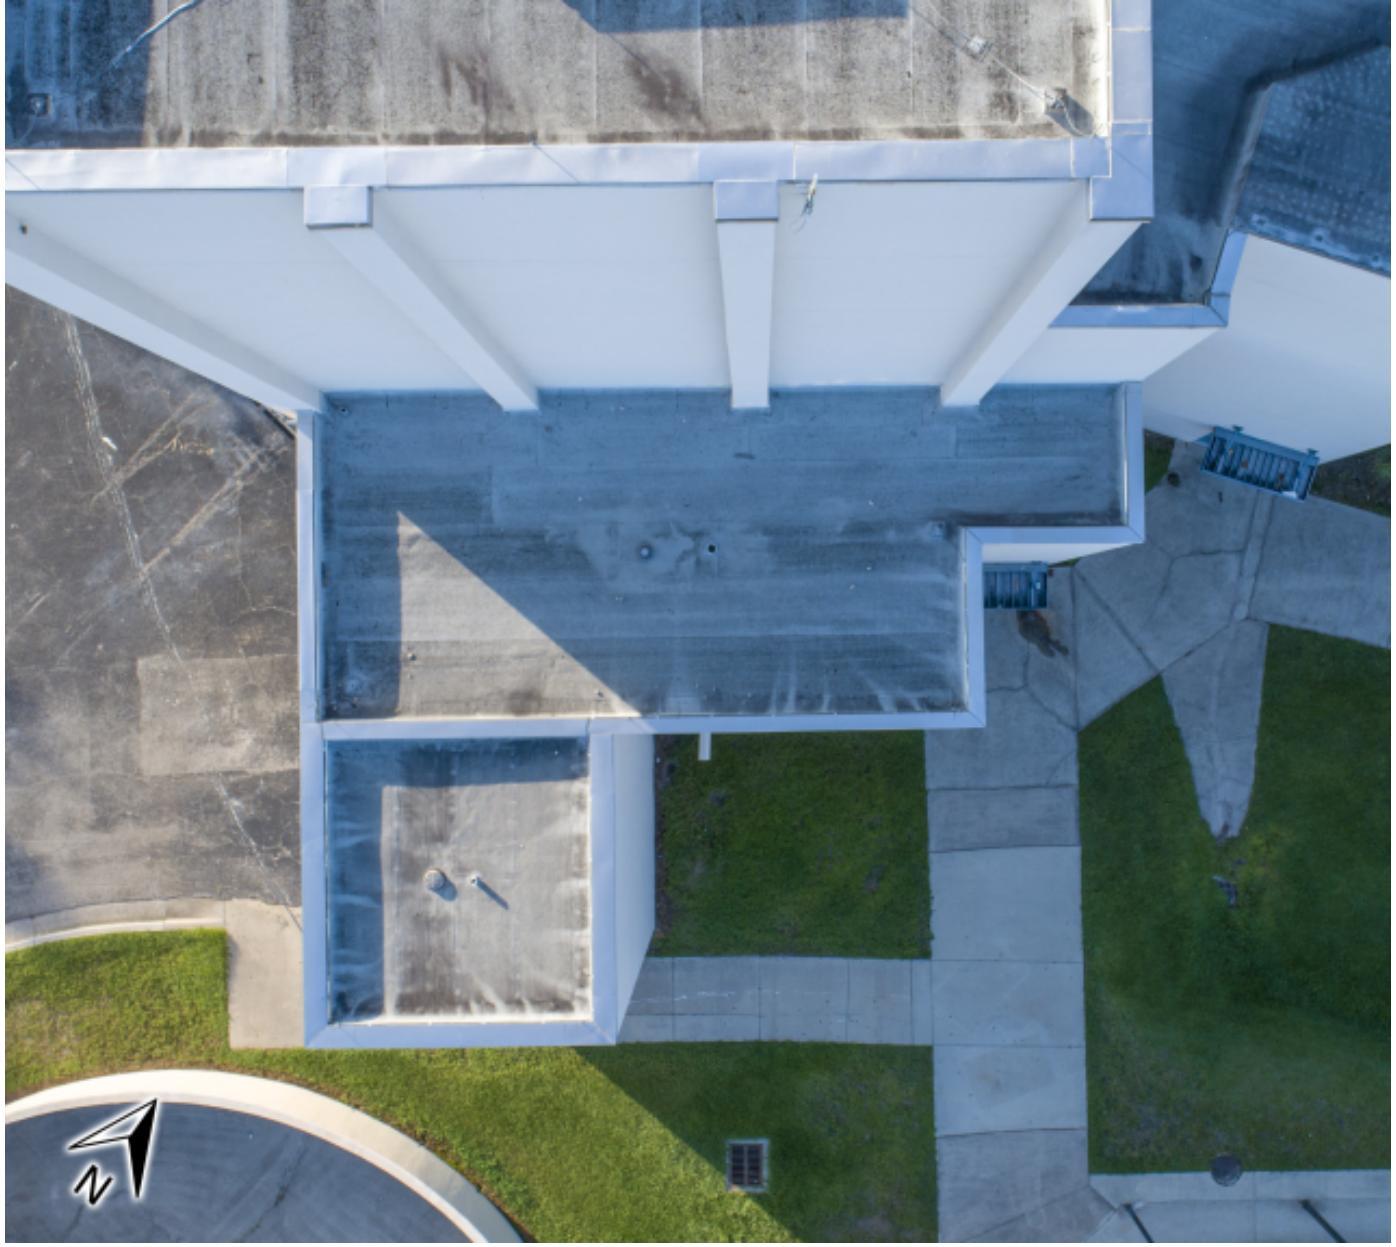
Building_18_East_Visible.jpg

Pictured here is Building 18's Eastern lower roof. This roof is modified bitumen. Noticeable stains and drainage flow patterns can be seen. Areas of concern that should be investigated will be marked on the following pages that include IR images of this roof.

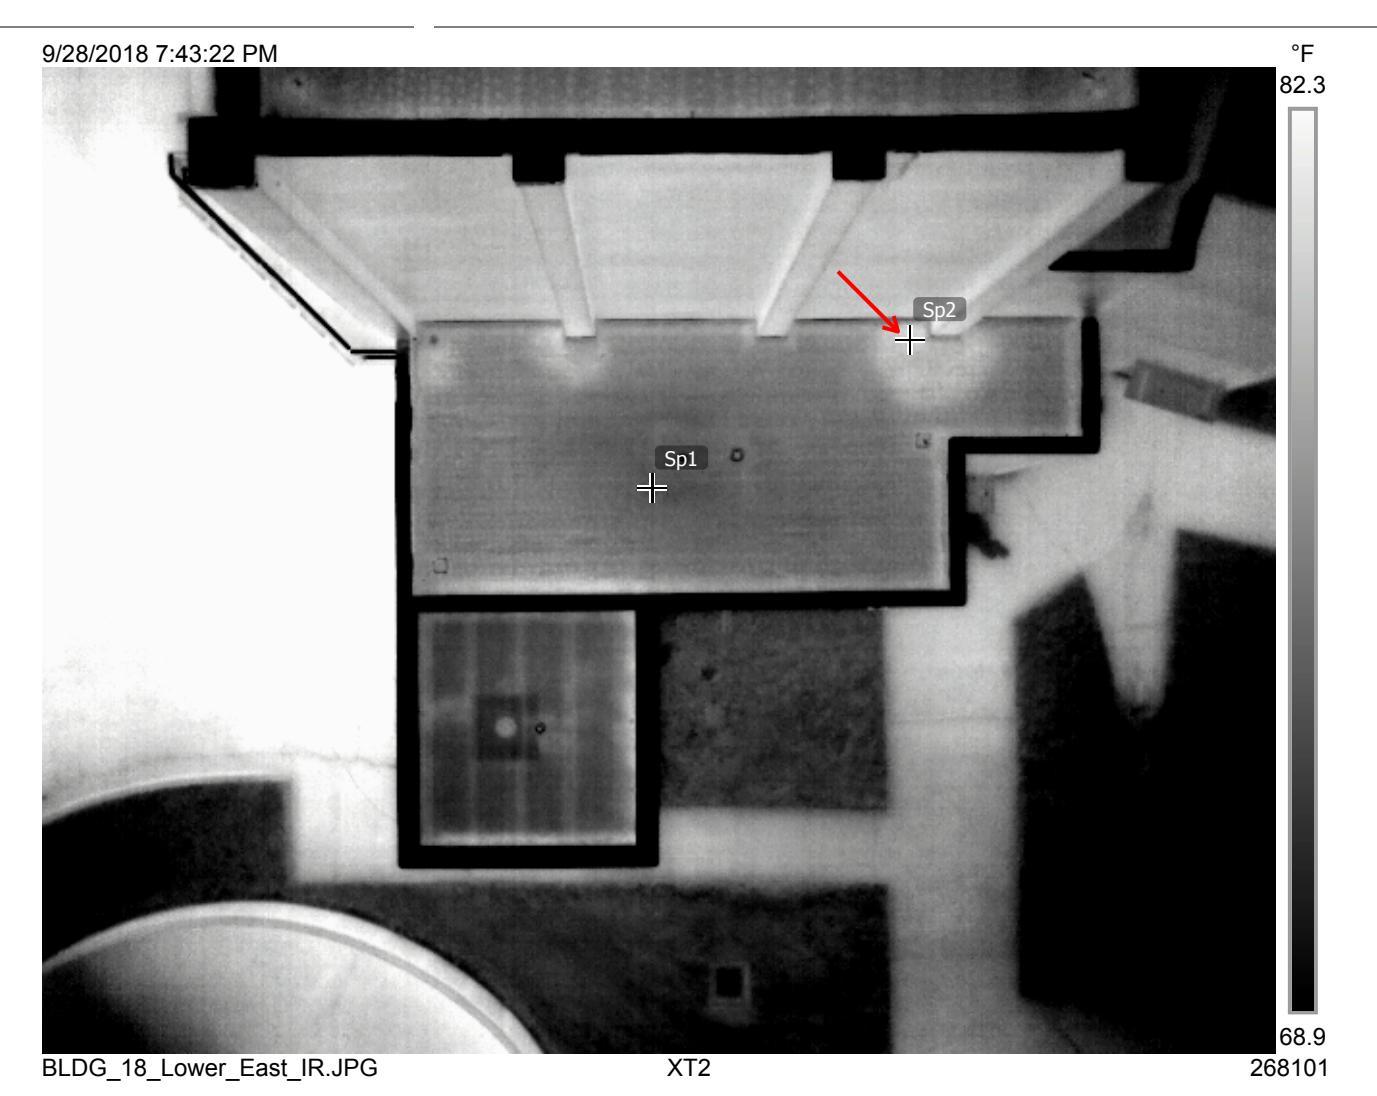
Text annotations BLDG 18 Lower East

Sp1		73.1 °F
Sp2		80.7 °F
Dt1	Sp1 - Sp2	-7.7 °F

The whiter areas indicate a higher temperature than the darker areas.

Recommend doing a core sample at the location of red arrow on this page and further physically investigate area with the red zebra pattern on the following

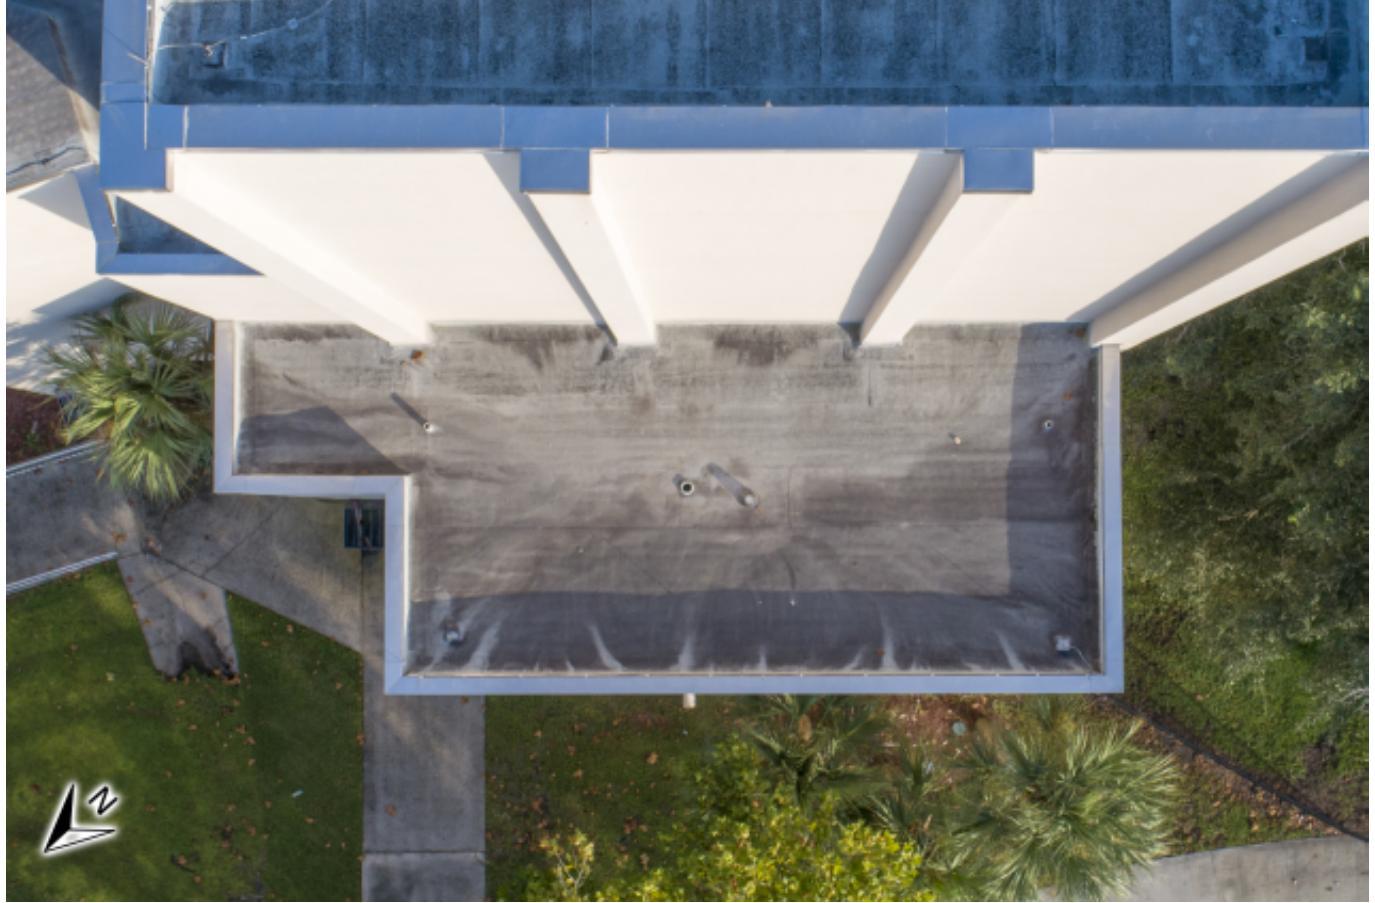
Building_18_West_Visible.jpg

Pictured here is Building 18's Western lower roof. This roof is modified bitumen. Noticeable stains and drainage flow patterns can be seen. Areas of concern that should be investigated will be marked on the following pages that include IR images of this roof.

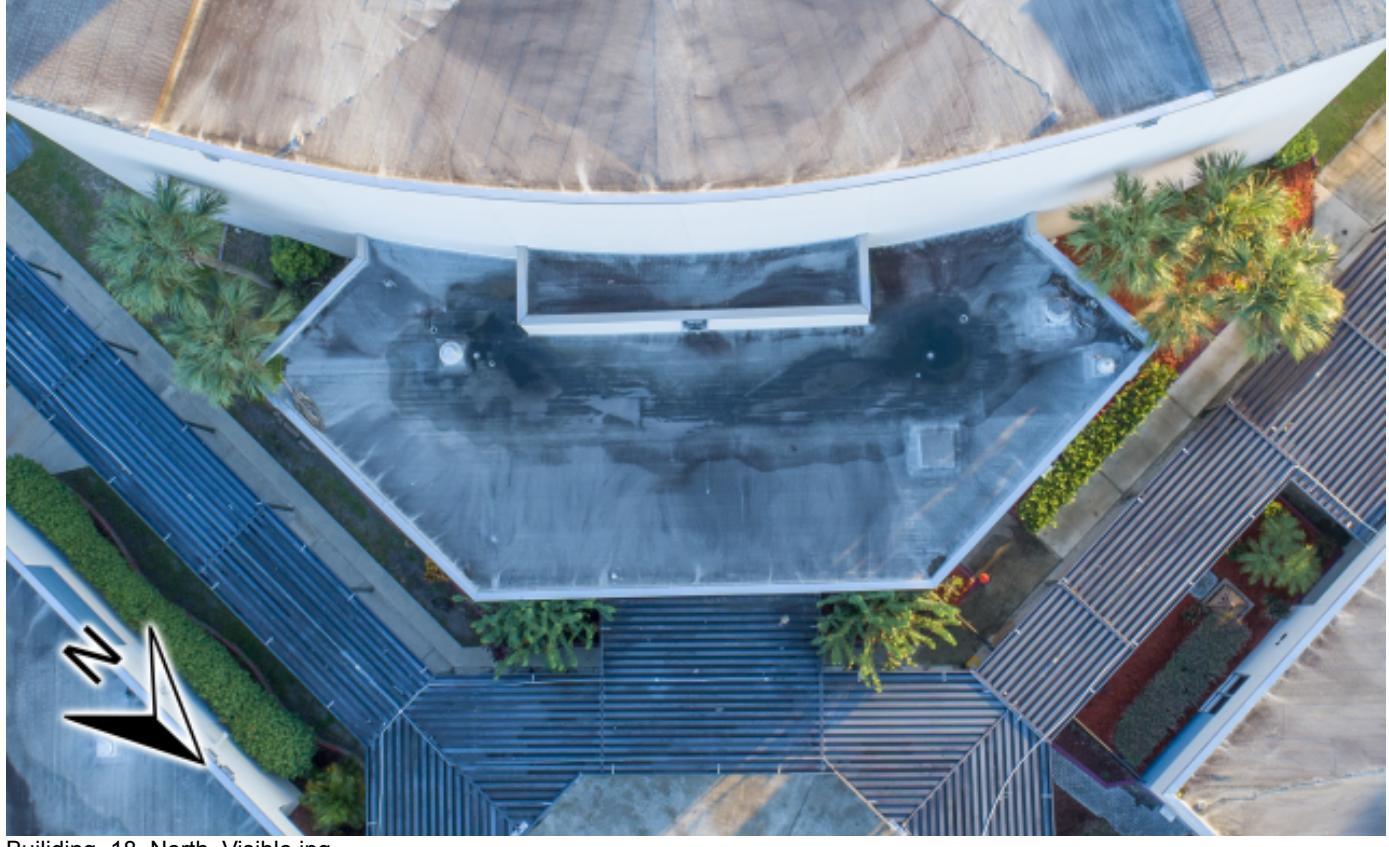
Builiding_18_North_Visible.jpg

Pictured here is Building 18's Northern lower roof. This roof is modified bitumen. Noticeable stains and drainage flow patterns can be seen. Organic debris is also visible. Areas of concern that should be investigated will be marked on the following pages that include IR images of this roof

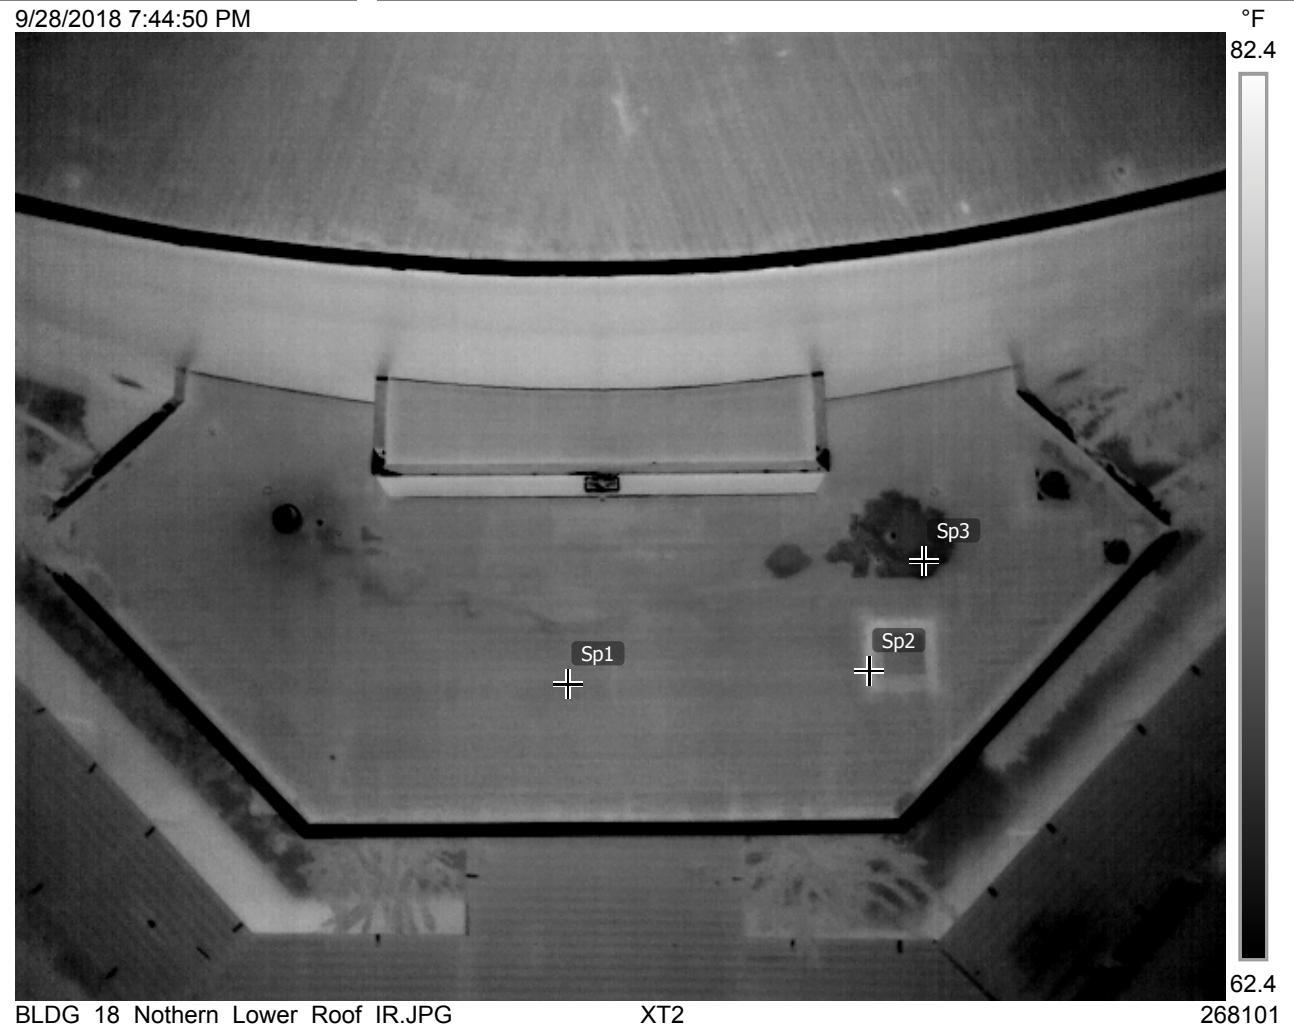
BLDG_18_Nothern_Lower_Roof_IR.J	PG
---------------------------------	----

Measurements			
Sp1		70.7 °F	
Sp2		74.7 °F	
Sp3		64.1 °F	
Dt1	Sp1 - Sp2	-4.0 °F

The whiter areas indicate a higher temperature than the darker areas. The darker, cooler, areas including Sp3 are caused by granular build up. On the following page these areas are marked by an orange zebra pattern.
