Thermal Imaging Date: Thursday March 1st 2018 Time of Thermal Imaging: Approx. 7:15 P.M CST. Sky Conditions: Clear at scan - Daytime Partly Cloudy. Daytime Temperature High: 73 Degrees Fahrenheit Temperature at time of Infrared Imaging: 61 Degrees Fahrenheit Wind Speed: 13mph NNE Humidity:67%

Imaging Performed by: Todd A. Hillhouse (Level III Thermographer) Roofing Surface: Modified Bitumen Surface Condition: Dry at surface. Roof had been swept and dried prior to scan. Infrared Camera Type: Zenmuse XT-R Powered by FLIR 30hz 640x512 13mm Imaging Altitude: 100 ft AGL - 300 ft AGL

QUALITATIVE INFRARED REPORT Building: Corporate Data Center w/ Low Slope Roof Roof Surface: Modified Bitumen City/State: San Antonio, TX

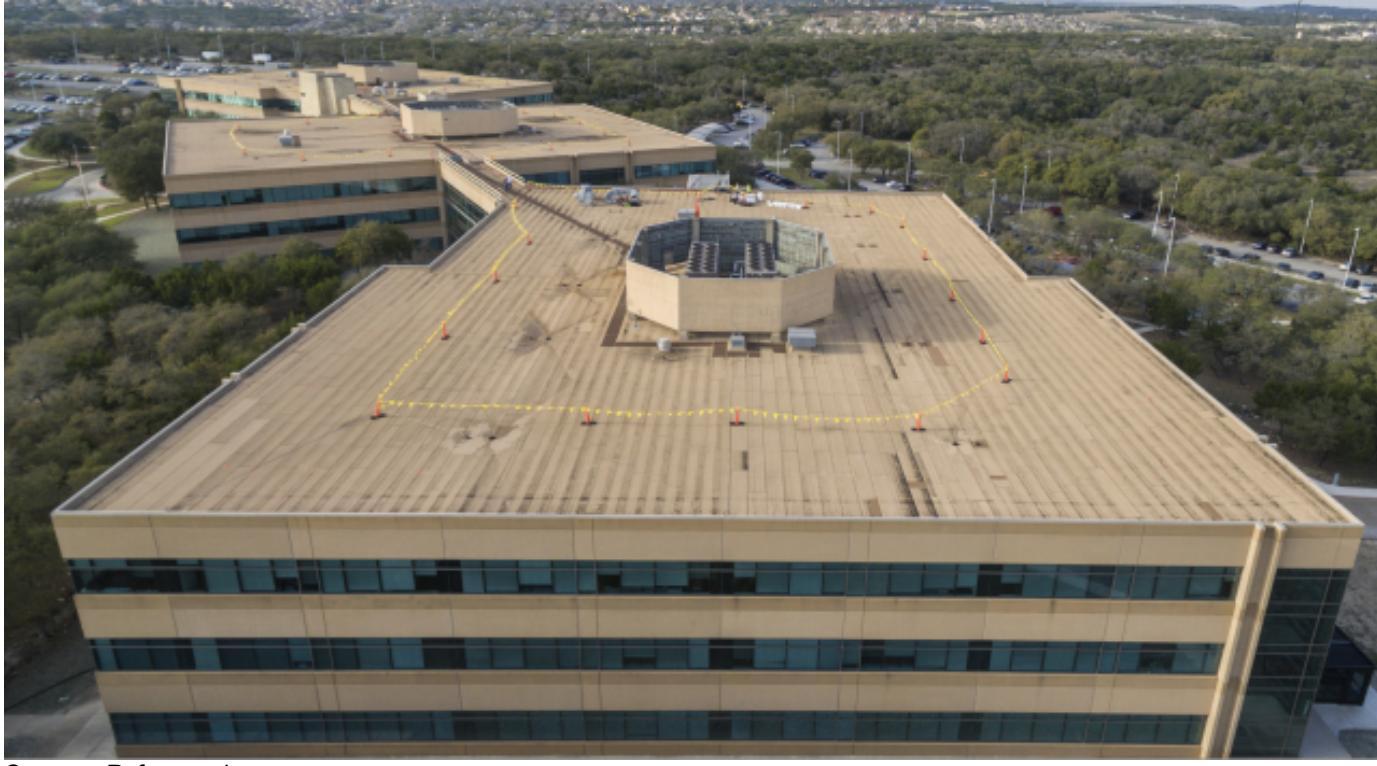
Campus_Reference.jpg

Visible and Infrared Images were taken 3/1/18 of Buildings A, B and C. During the infrared imaging some wind gust did occur but did not appear to affect the IR imaging. Analysis of IR images will be further detailed on the following pages specific to each building.

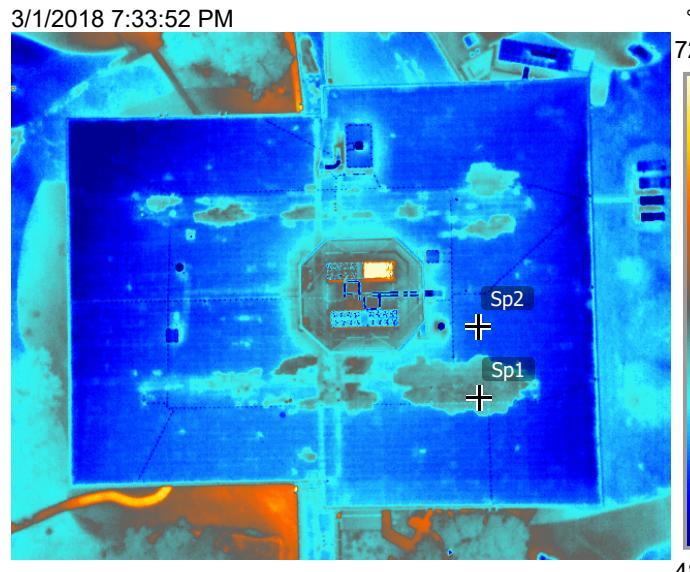
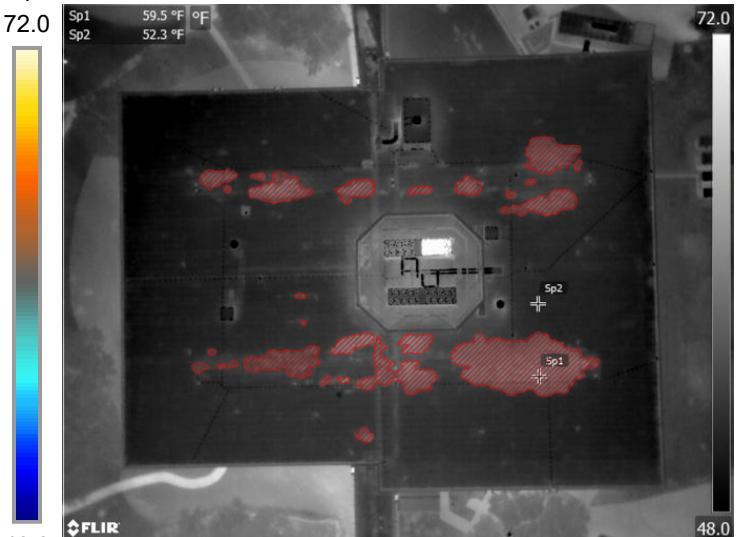
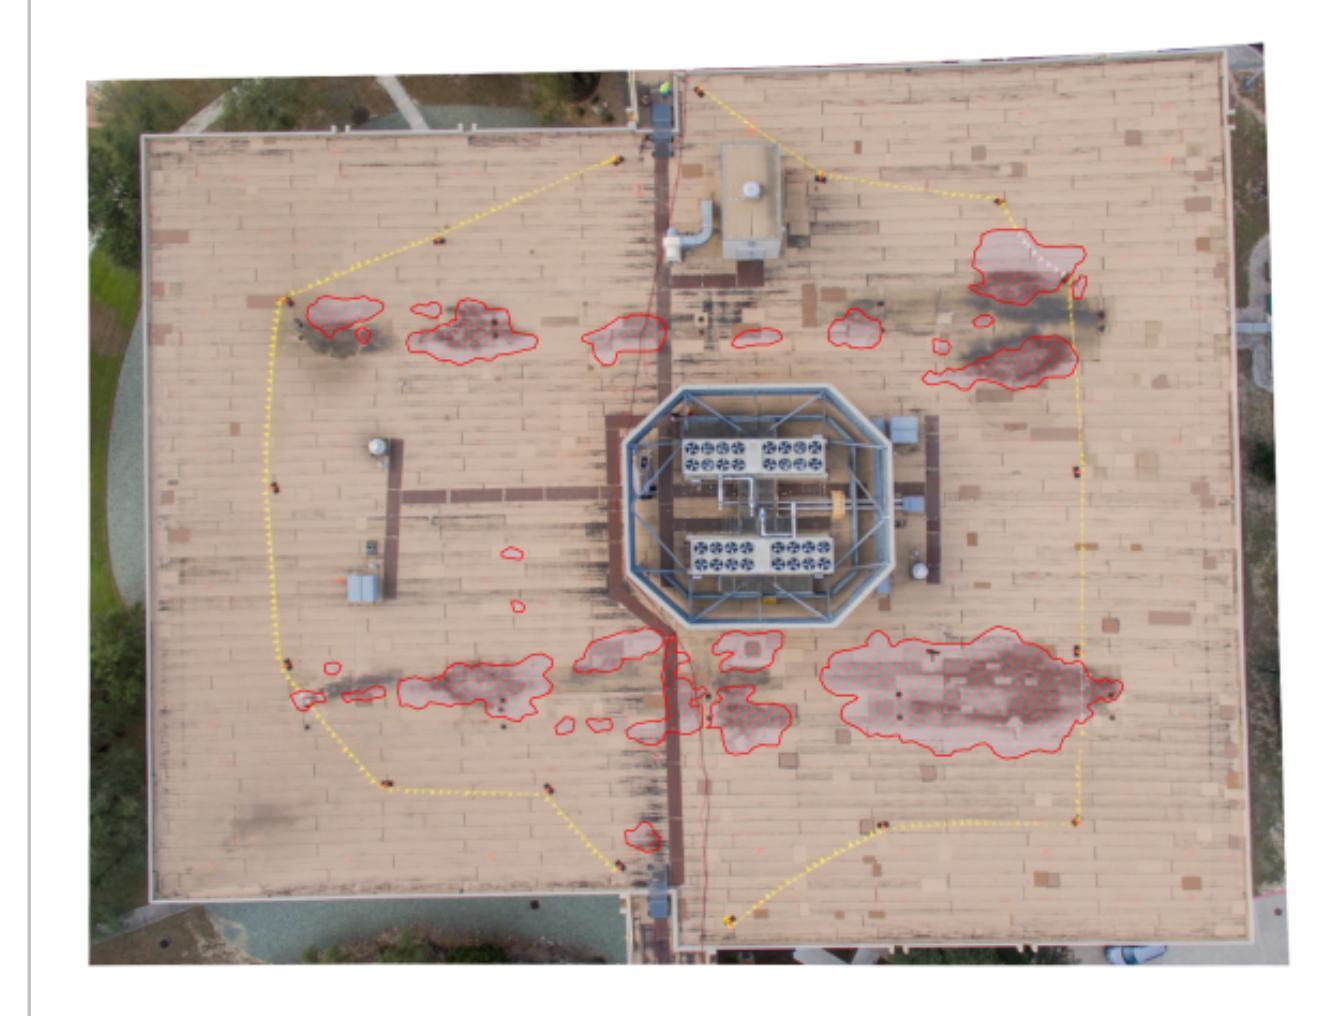
48.0 Building_B_IR.jpg

Pictured here is Building B. Many noticable dark stains along with loose granules can be seen. Areas of concern that should be investigated will be marked on the following pages that include IR images of this roof. The Infrared images will show anomalies that extend out far past the stains.

Recommend doing a core at the location of red arrow. Spot 1 is several degrees higher than spot 2. The white areas indicate a higher temperature than the darker areas. The white areas extend out past the visible image stains, indicating not just a difference in material but a temperature anomaly that needs to be investigated. These areas of concern will be marked with red zebra pattern on the following page.

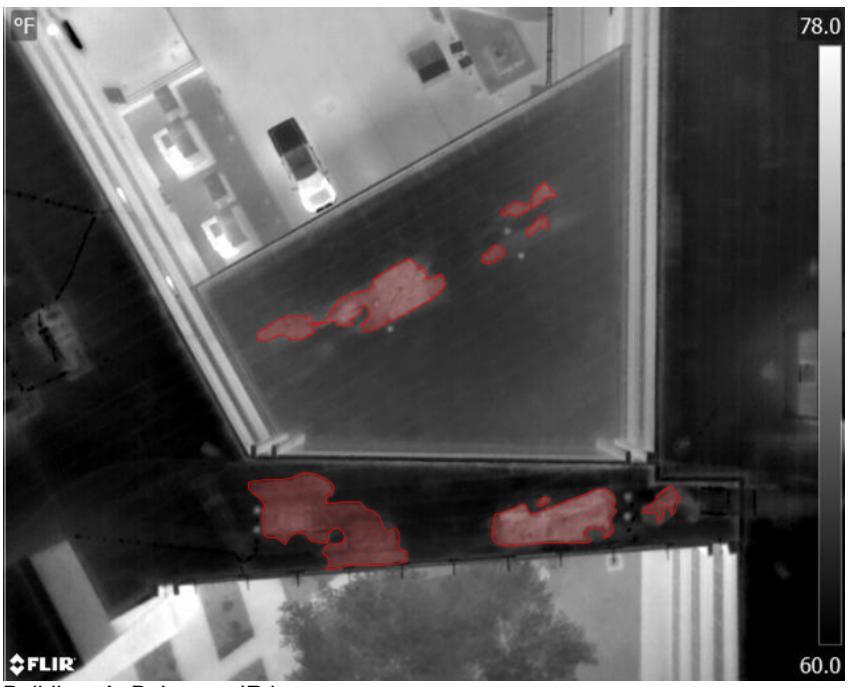
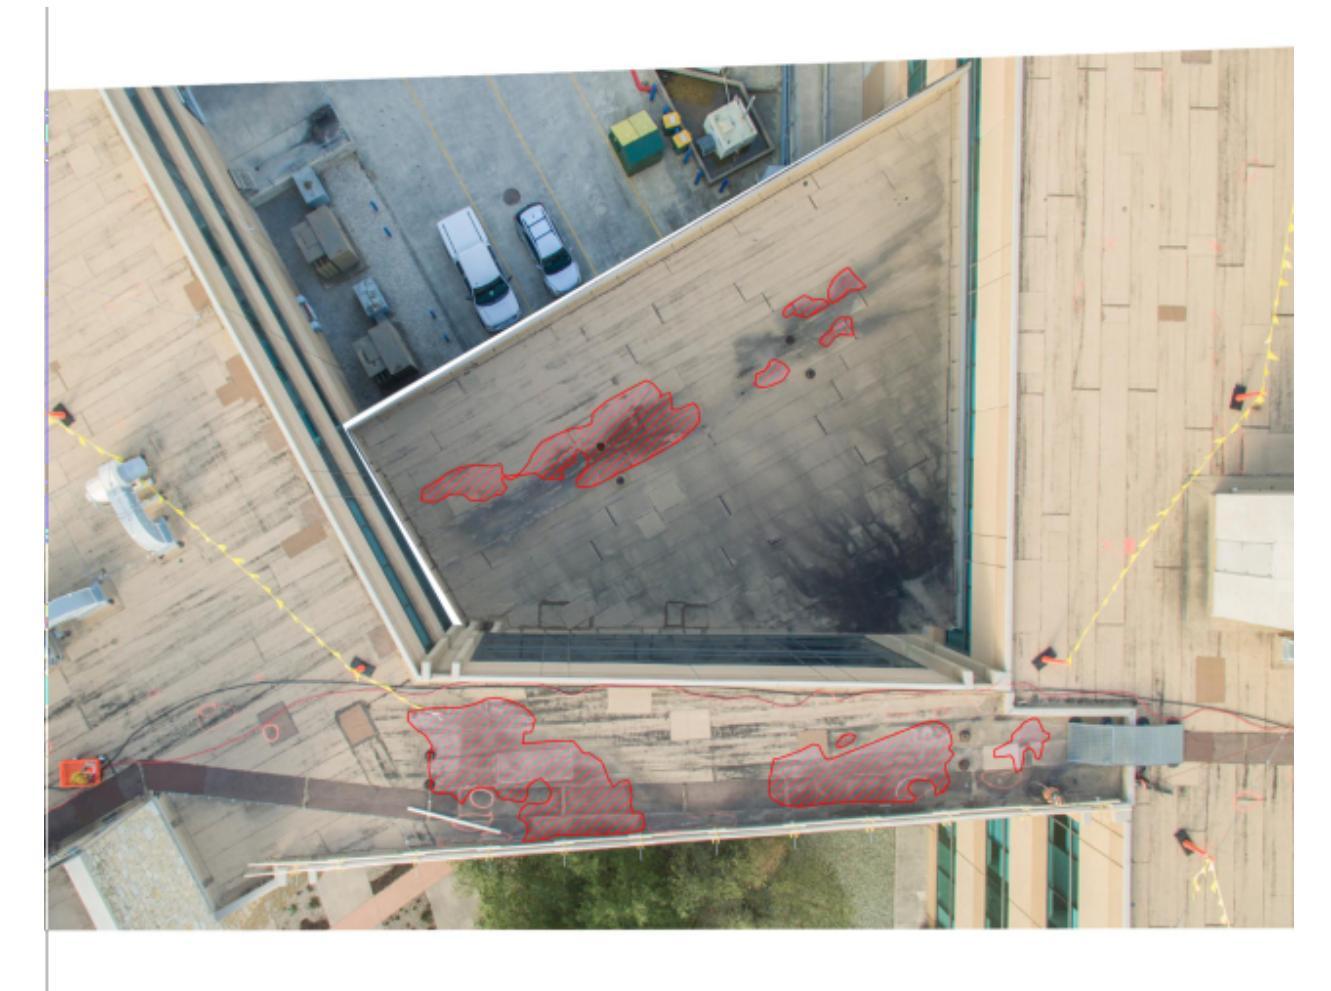
Building_A_B_Lower_IR.jpg

Pictured here is the lower roof and walkway between Buildings A and B. Many noticable dark stains can be seen. Areas of concern that should be investigated will be marked on the following pages. Recommend doing a core at the location of red arrows. Areas of concern are marked on the following page with red zebra pattern.

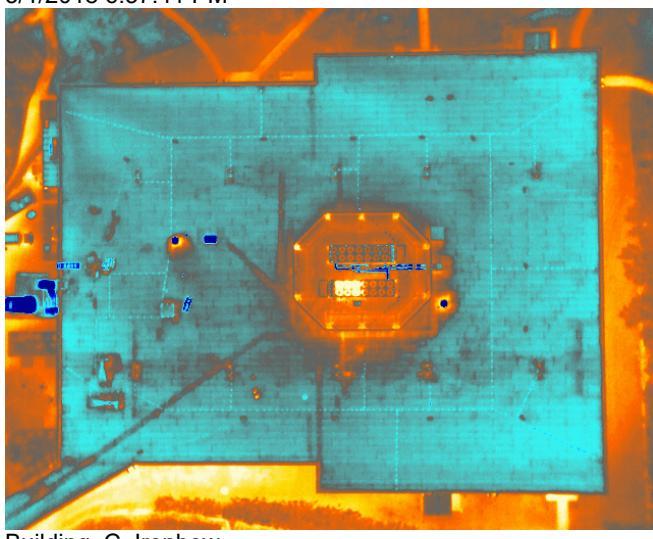
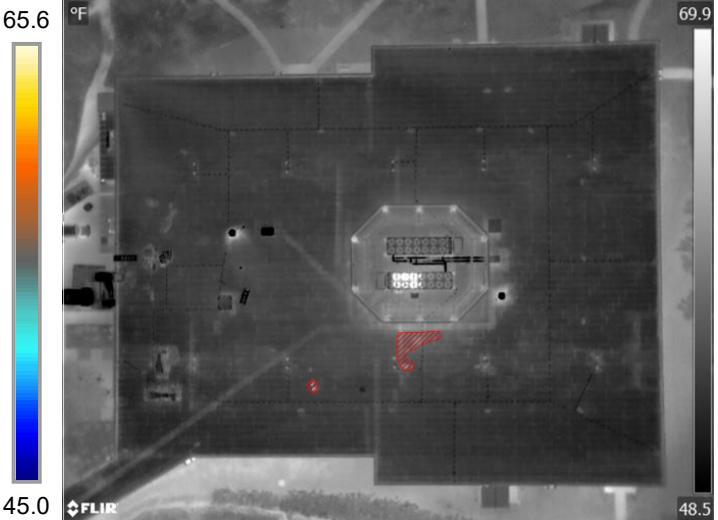
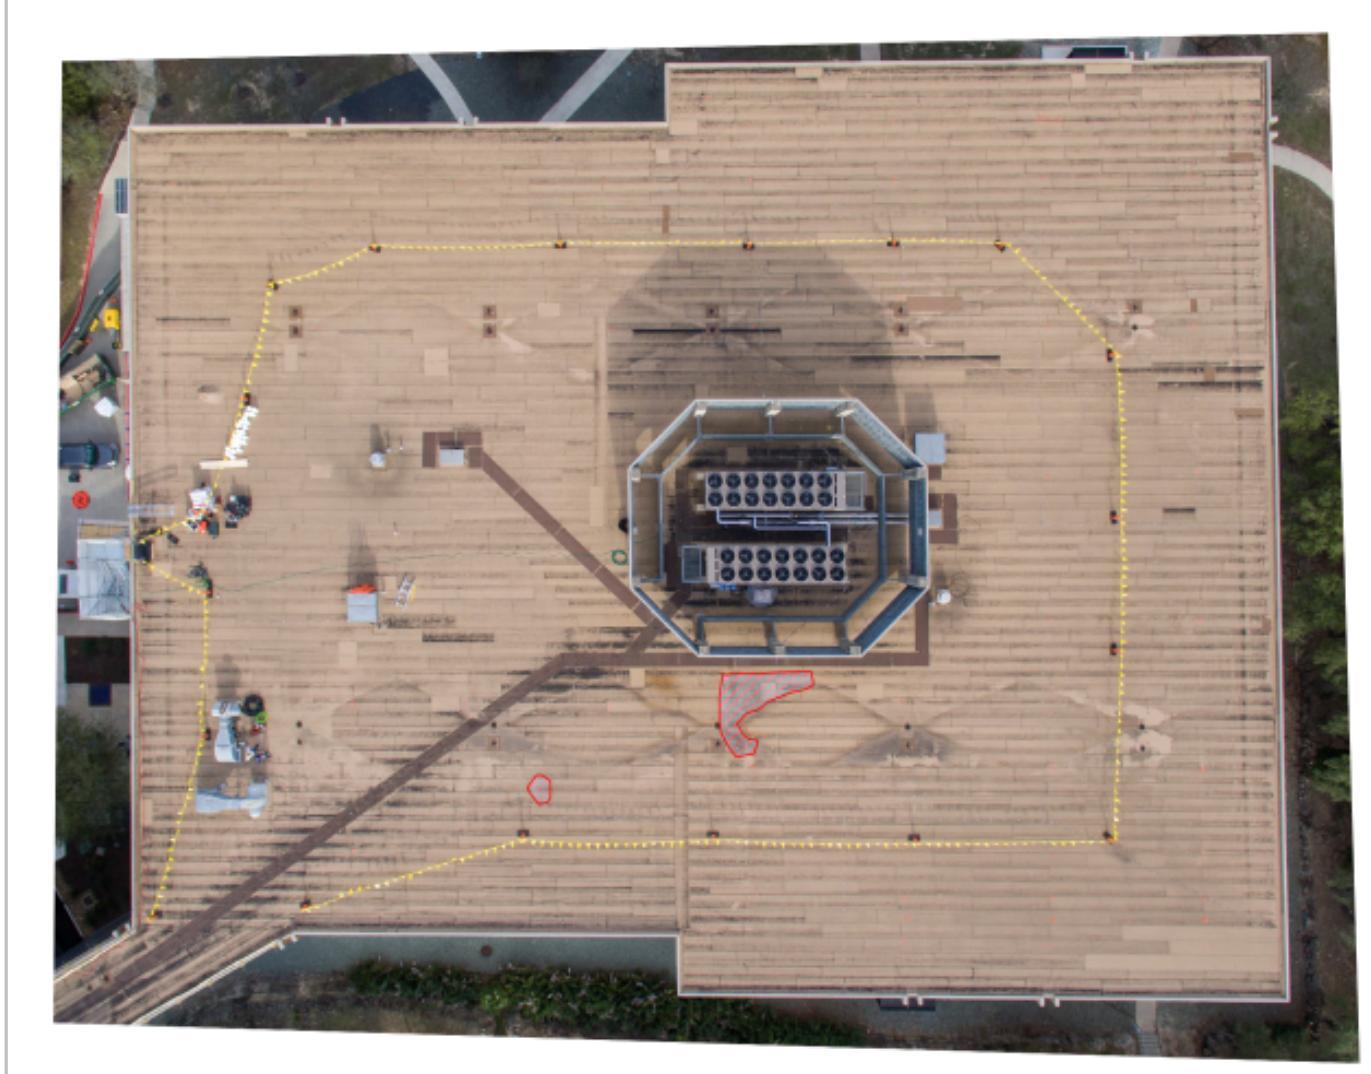
Building_C_IR.jpg

Pictured here is Building C. A few noticable surface stains along with loose granules can be seen. There was some material and equipment staged on this roof that will show up in IR images. Areas of concern that should be investigated will be marked on the following pages that include IR images of this roof. Overall this building showed very few anomalies appearing in the Infrared Imaging.

Overall very few anomalies that would indicate moisture penetration were found on this roof.

Recommend doing a core at the location of red arrows.
